# Great Musgrave EDE/25

*Report for The HRE Group*

*Revision A, 9 May 2022*

Great Musgrave Bridge is a single span masonry bridge carrying a minor road over the trackbed of the former Eden Valley Railway (EDE). The structure number is EDE/25.

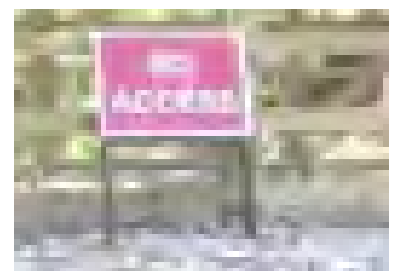
Figure 2.1: Excerpt of photo 5 from 2017 exam, showing image quality degradation from compression. The quality issue is striking here because of the sharp edges in the sign. Across the rest of the image the same compression eliminates all fine detail.

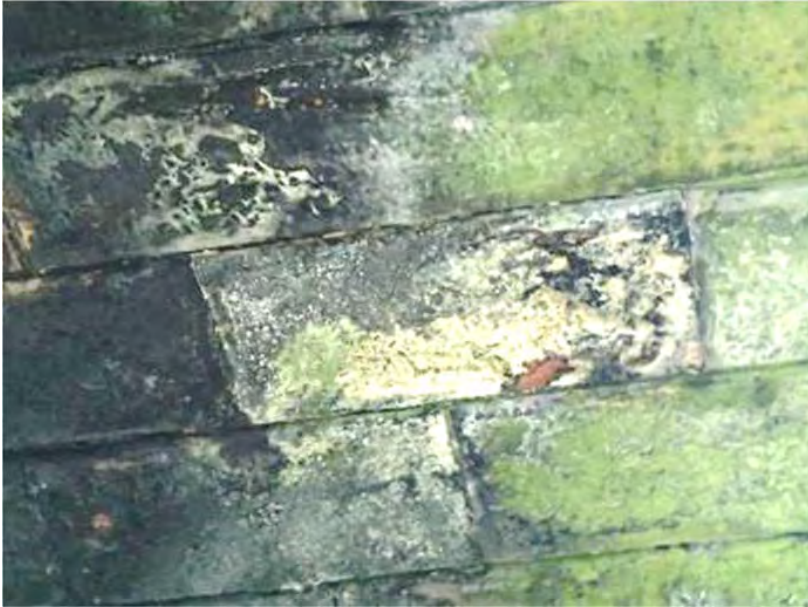
*Photos 11-13, “Example of long-standing downward alignment defects.”*

Figure 2.2: Photo 12 from 2020 visual, showing dropped stone. Quality is limited but exposed edge does not look at all different. We would expect a cleaner face in a recently dropped stone, and abrasion or damage in a stone dropping due to mechanical action.

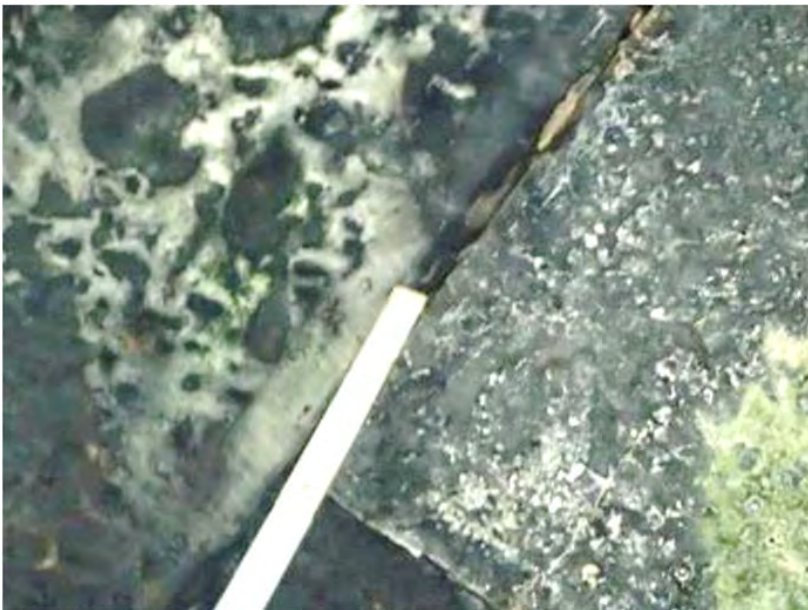
Figure 2.3: Photo 13 from 2020 visual, showing dropped stone with ruler. Ruler sits within chamfer at corners of stones. Where and how was the drop measured on each occasion?

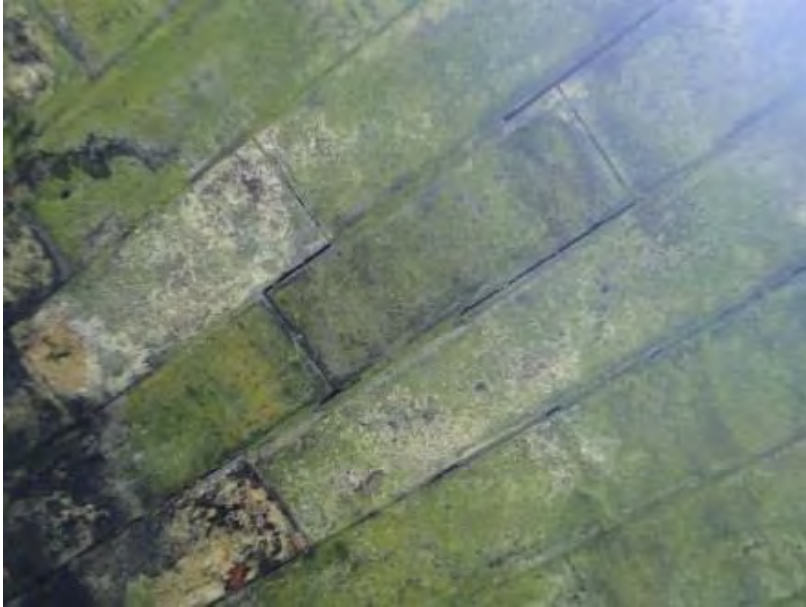
Figure 2.4: Example of open joints, presented as photo 14 in 2020 visual inspection report. The voids are over limited lengths of joint; there remains ample area to carry the thrust.

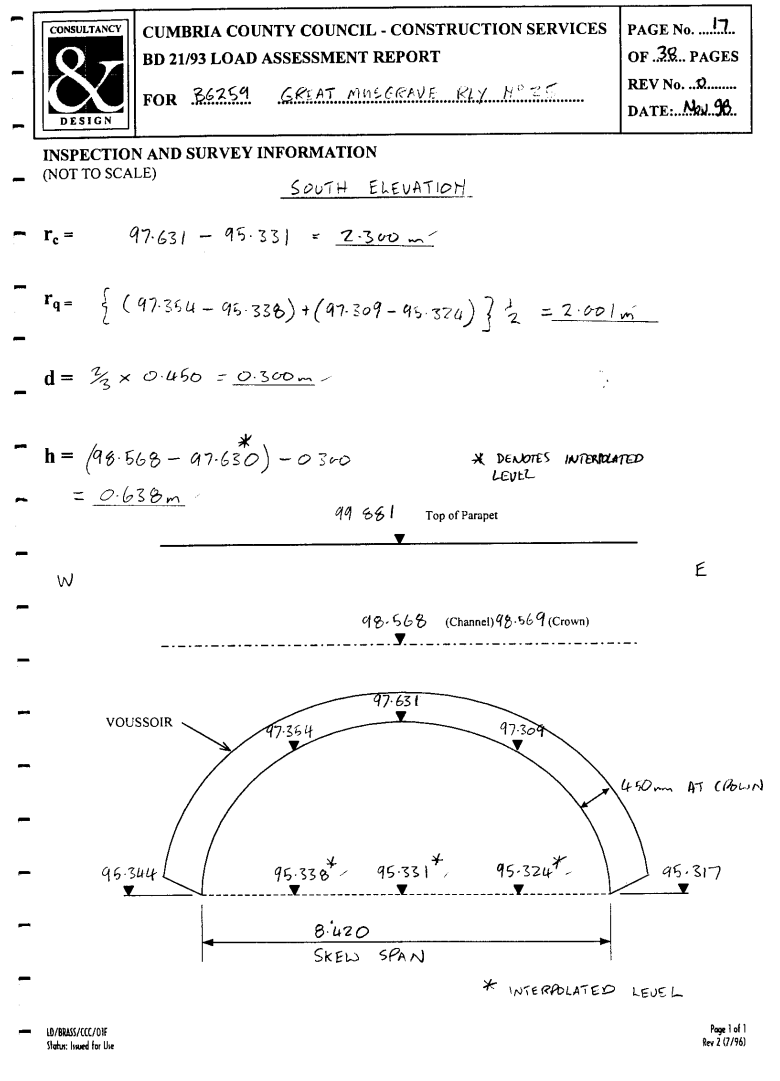
Figure 4.3: South elevation dimensions from 1998 assessment report.

Figure 4.3 shows the south elevation dimensions. These are shown as levels, measured at the springings, quarter points, and crown.

We do not know how these levels were obtained. Measurements are reported to the nearest millimetre, which is unjustifiable whatever the method. The level difference at the springings of 30 mm is surprising and would warrant comment and checking. Quarter point measurements are particularly difficult, as they are very sensitive to position in the span.

So the shape is within measurement error of a true ellipse.

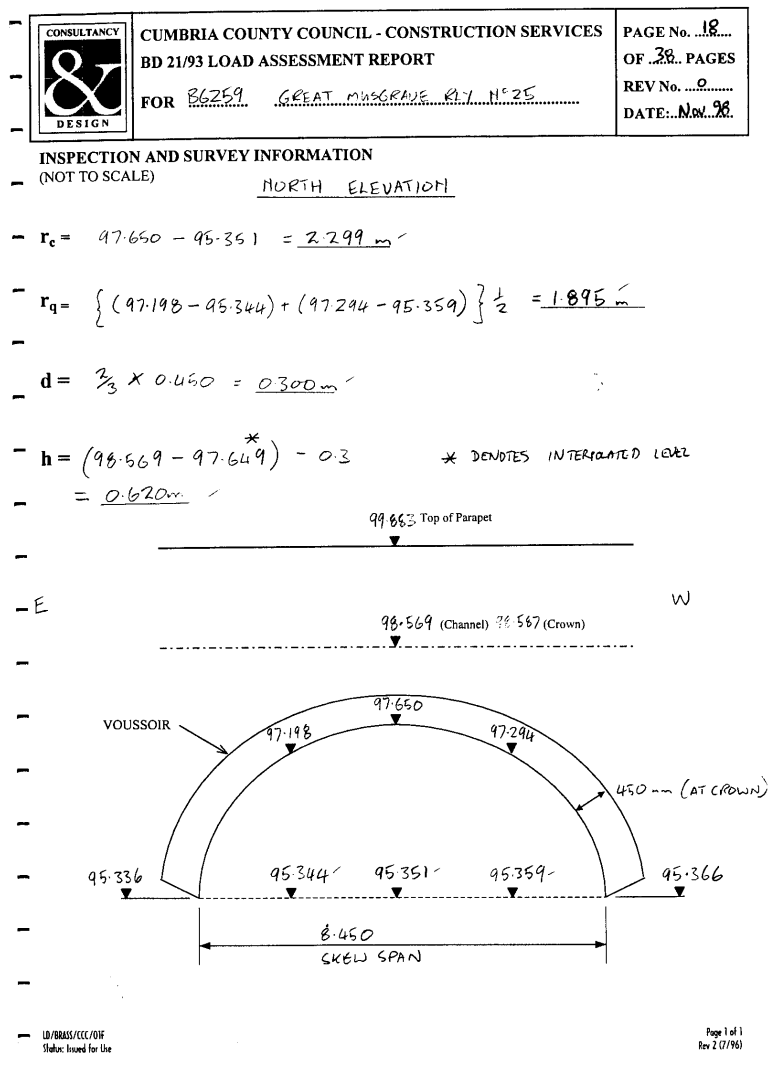
Figure 4.4: North elevation dimensions from 1998 assessment report.

Looking now at the north elevation, dimensions in figure 4.4, things get less convincing. The 20 mm difference in level between the abutments is repeated here, but a drop of this scale across the span would show as distress in the spandrel wall masonry. A 20 mm level difference between elevations is also suggested, and

such a slope across the abutments would be quite visible if one looked along the string course at the springing.

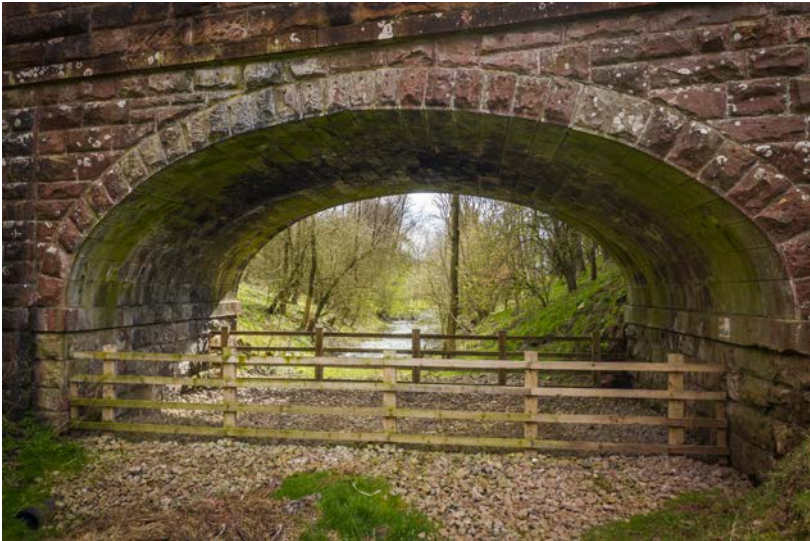
Figure 5.1 gives a view of the elevation and soffit. The water marks suggest backing at least to the sixth voussoir from the end but more likely the ninth, which would be more or less level with the arch crown intrados.

Figure 5.1: A recent photograph showing elevation and soffit.

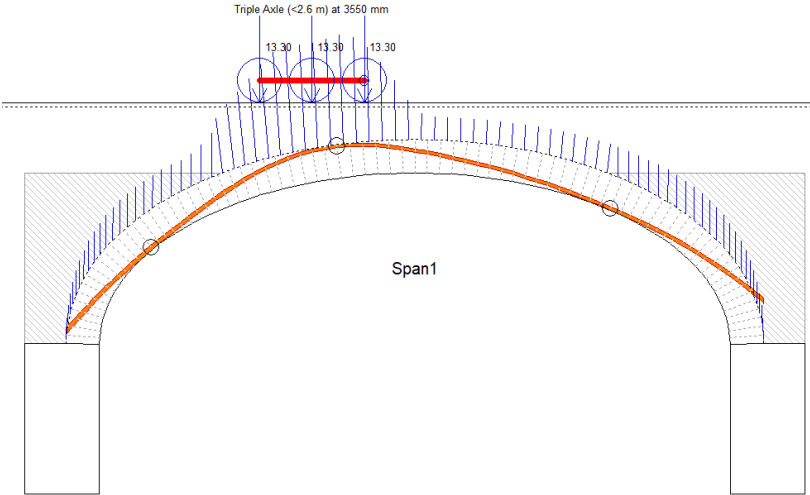
On that basis, the bridge would suffer no damage from any AWR vehicle. The worst case would be as shown in figure 5.2. For loads with impact, the worst case is shown in figure 5.3

Figure 5.2: Worst case AWR load for Great Musgrave geometry, with backing to crown intrados level.

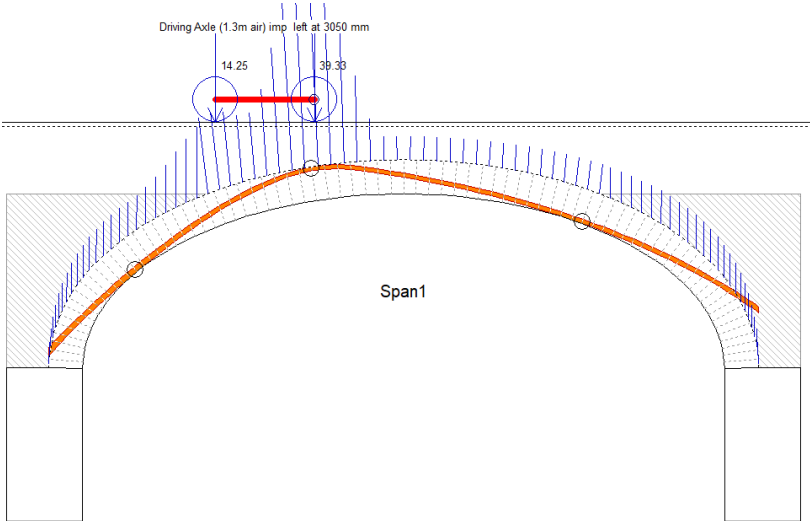
Figure 5.3: Worst case AWR load with impact for Great Musgrave geometry, with backing to crown intrados level.

Sensible application of either Modified MEXE or the Archie-M approach shows a capacity in excess of that required for 44 tonne vehicles.

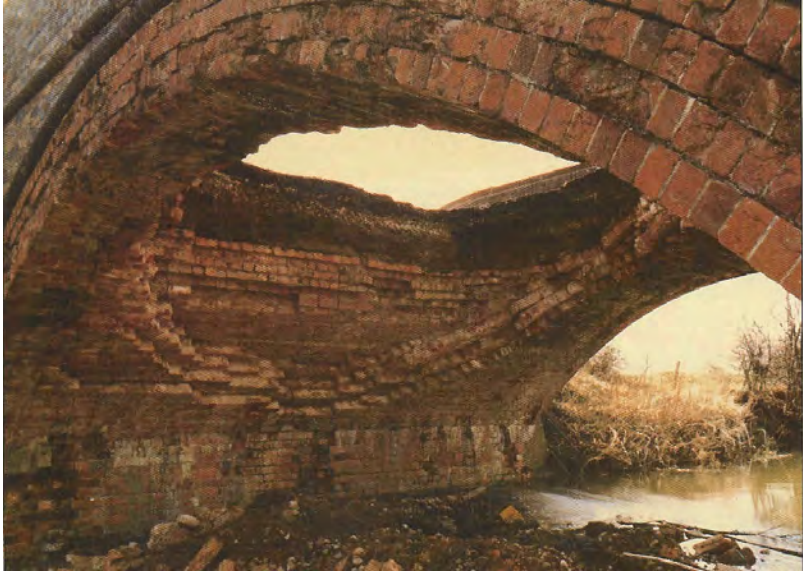
Figure 6.1: A masonry bridge in which the arch ring dropped out.

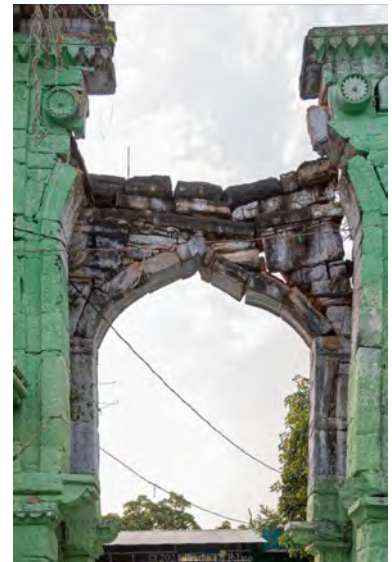
Loss of containment to the abutments can lead to gradual failure and could lead to collapse. This scenario is well illustrated by figure 6.2, which also shows clearly just how far the abutments need to move to allow not just distress, but collapse.

Figure 6.2: Impending collapse of a decorative stone arch, showing the degree of abutment movement required to allow this.

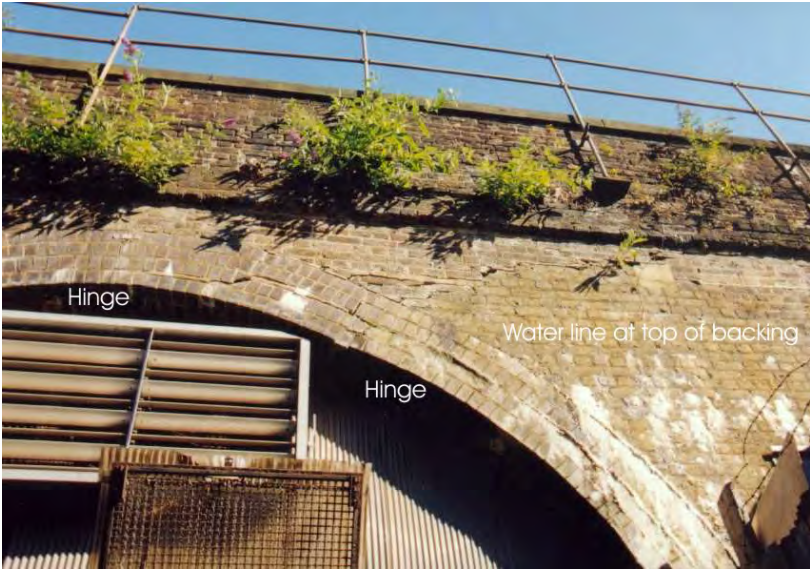
Examples of the former are less numerous but not uncommon. Figure 6.3 shows part of an arch near Raymouth Road in London, where a pier suffered about 100mm subsidence. This elevation is inaccessible, and the movement probably developed slowly over many years. The railway above was unaffected, though presumably the track was realigned to compensate at intervals.

Figure 6.3: Damage resulting from a pier dropping around 100mm. The structure continued to carry rail traffic without risk of collapse.

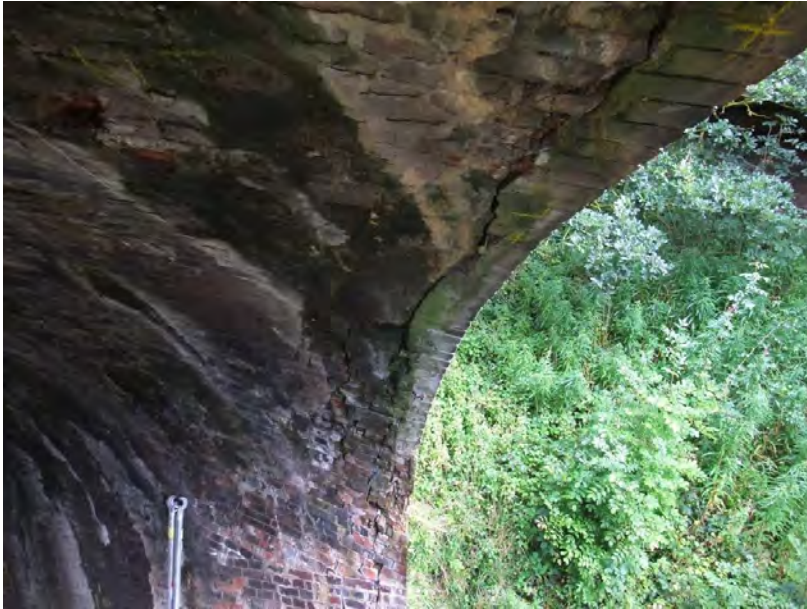
Figure 6.4: Damage to brick bridge at Great Dunchurch. Cyclic live loads have caused a crack to develop through the ring where the spandrel wall stiffens the edges.

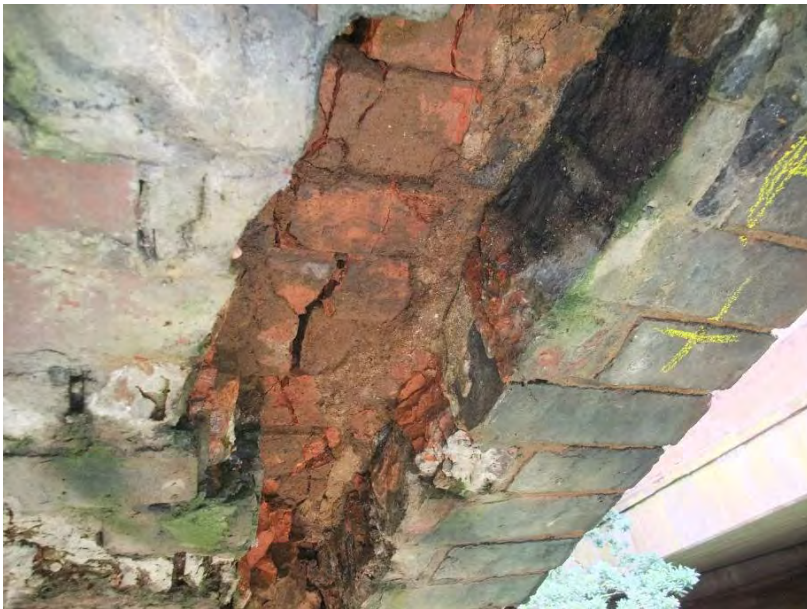
Figure 6.5: Here, the crack has bifurcated, creating an island patch which has then fallen out.

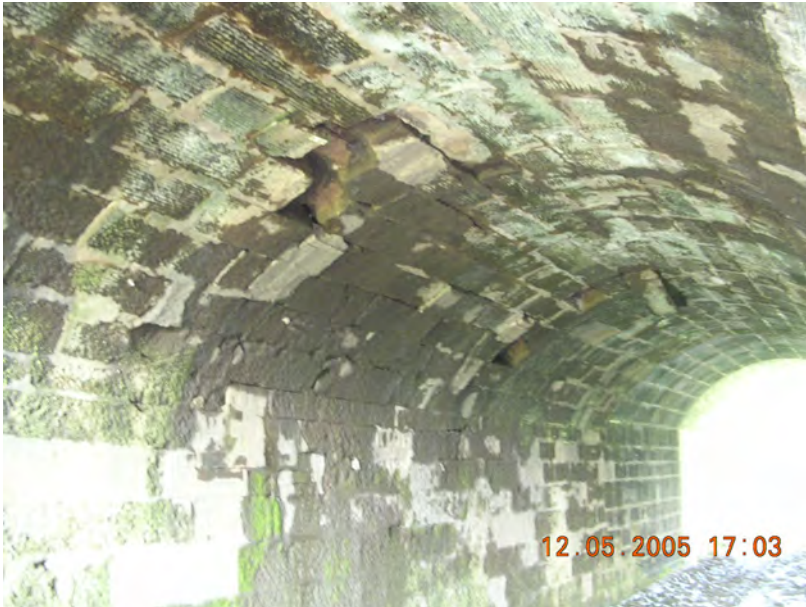
Figure 6.6: Severe damage to a bridge, with stones dropping due to mechanical action.

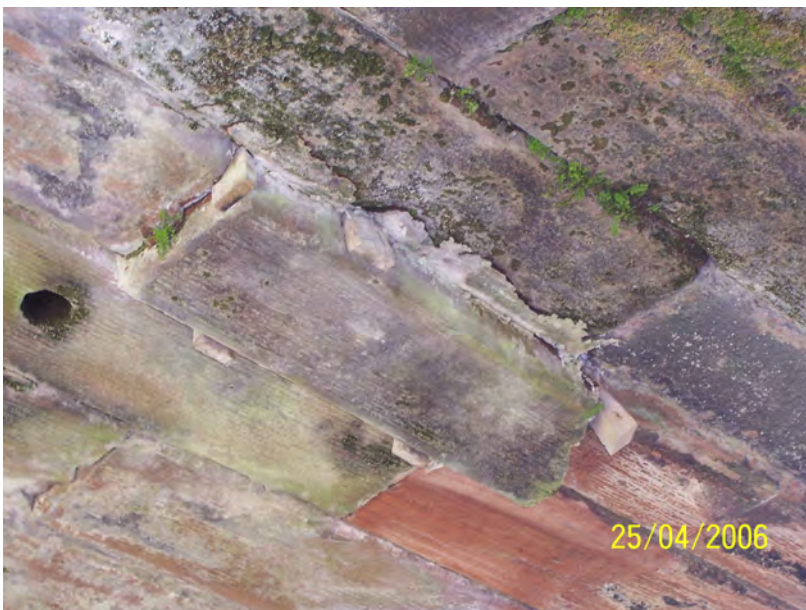
Any one stone could only drop as far as the neighbouring stones allowed. Figure 6.7 shows how spalling of the next stone is required to allow further movement.

Figure 6.7: A single dropped stone due to mechanical action. Note the clear damage to the surrounding stone, without which the stone could not have dropped this far.
