BRIDGE ASSESSMENT TO BD21/97

B6259 - GREAT MUSGRAVE RAILWAY BRIDGE NO 25

BD 21/97 LOAD ASSESSMENT REPORT

ELR:	EDE	Structure No:	25	Mileage:	Examination date:	08/02/20
Route:	Eden	Valley Jn - Kirkby	Stephen ((Warcop Branch)	OS ref: NY 765 130	6
Name:	Great	Musgrave			Type: Over bridge

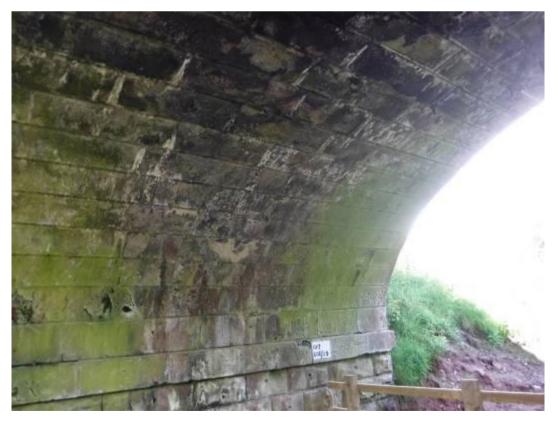
Photo No.13: Arch ring soffit: Former S&T fixing voids.

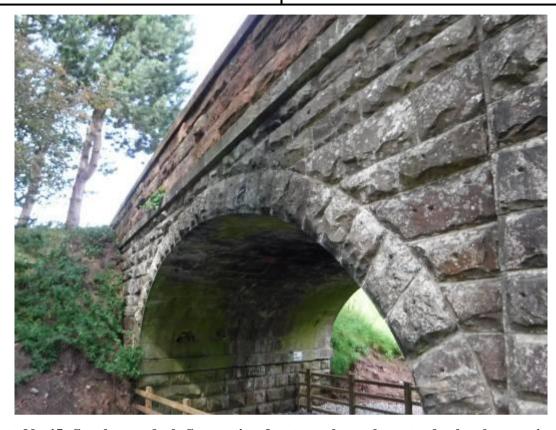
Photo No.45: South spandrel: Separation fracture above the extrados has been pointed.

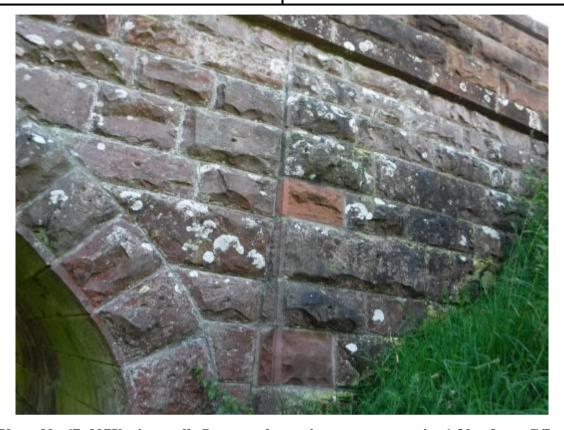
Photo No.67: N/W wing wall: Stonework repairs at return quoin, 1.30m from G/L.

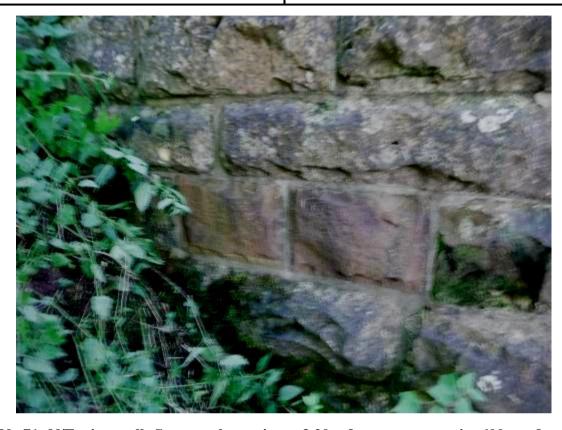
Photo No.71: N/E wing wall: Stonework repairs at 3.20m from return quoin, 600mm from G/L.

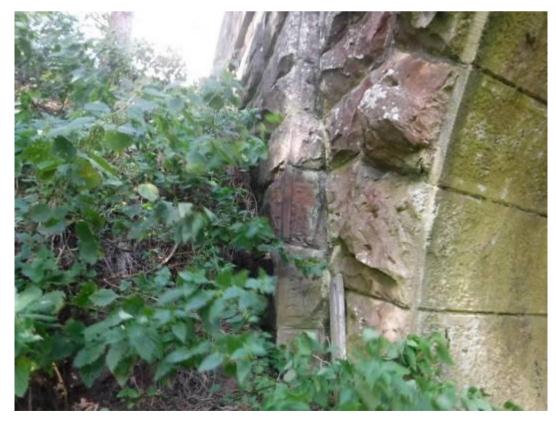
Photo No.76: S/W wing wall: Stonework repairs at return quoin, 550mm from G/L.

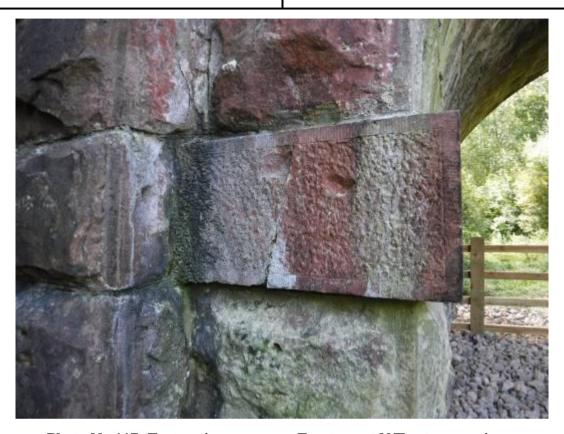
Photo No.117: East springer course: Fracture at N/E return section.
