14 April 2023

## BRP/8 Barrowland Lane bridge, near Toller Porcorum, Dorset

## **BRP/8 Barrowland Lane bridge: Engineering Appraisal**

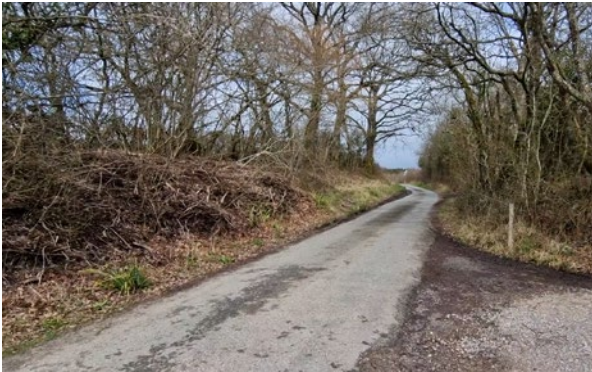
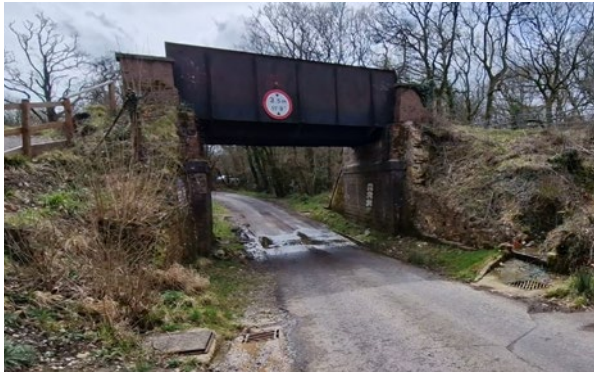
*The view north (left) and south (right) from the bottom of the temporary ramp on the north side of the bridge. Beyond the abutment, the bend in the road is obscured by trees (see south-facing photo on next page).*

From the bottom of the 'temporary' ramp, the bridge does not impede the visibility of traffic approaching from the south to any extent, but it does deter any cyclist heading down the ramp from riding straight out into the road without stopping.

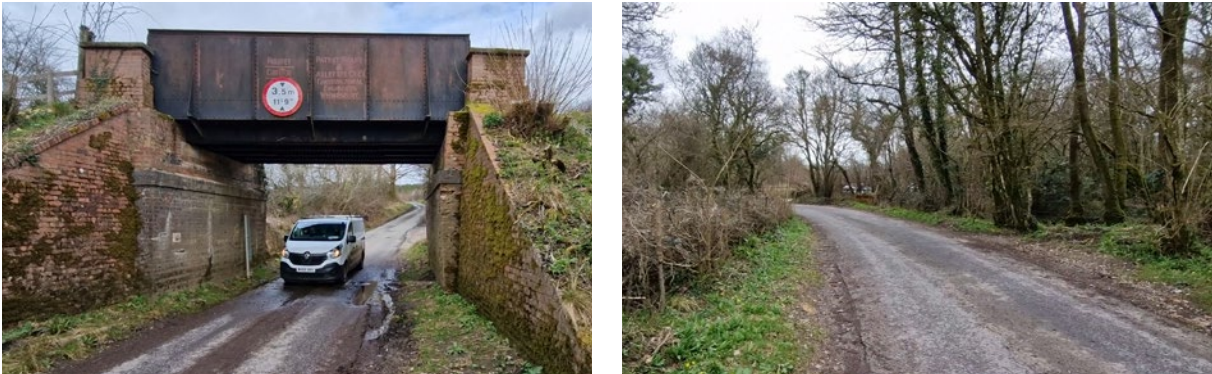
*The view north (left) and south (right) from the bottom of the originally intended ramp on the south side of the bridge. The blind bend presents the greatest risk to trailway users.*

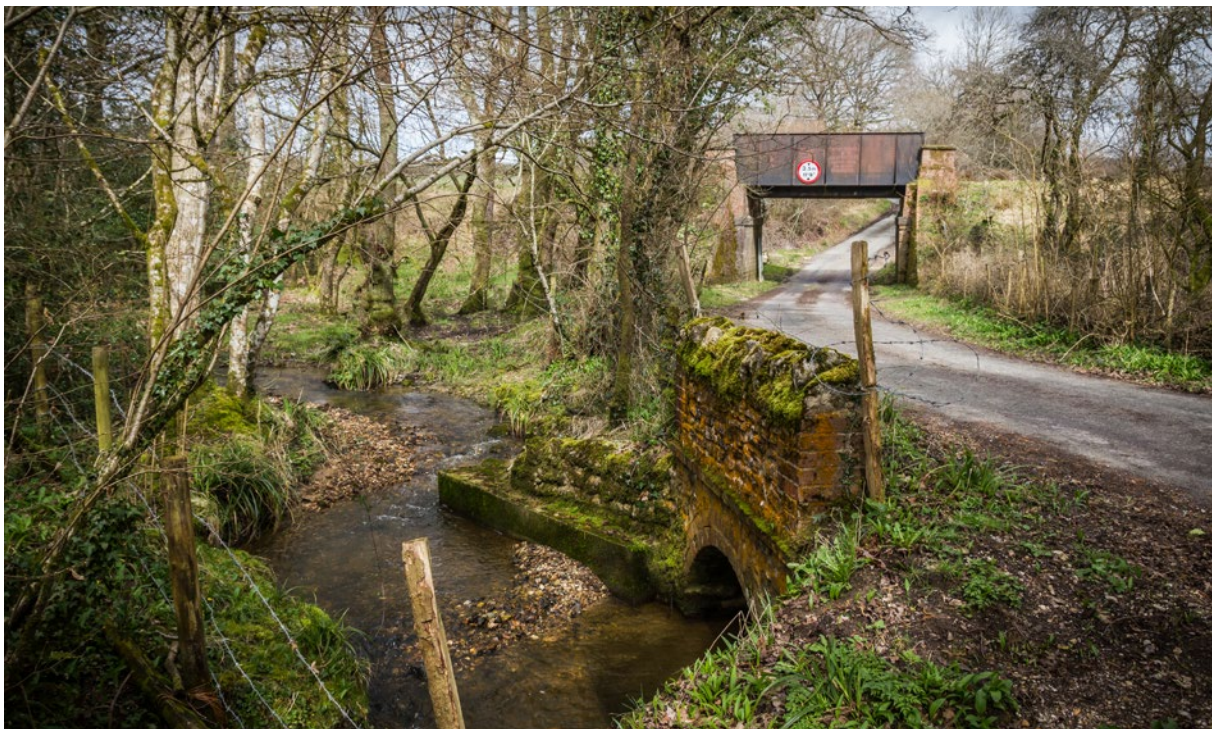
The confluence of two streams which pass under the road, forming Toller Brook.

The extent to which this watercourse contributes to the flooding is not clear. It was noted that channels appear to have formed through the otherwise raised verge on the west side of Barrowland Lane but, to overtop onto the road, the water level would have to be considerably higher than on the day of our visit, after heavy overnight rain.

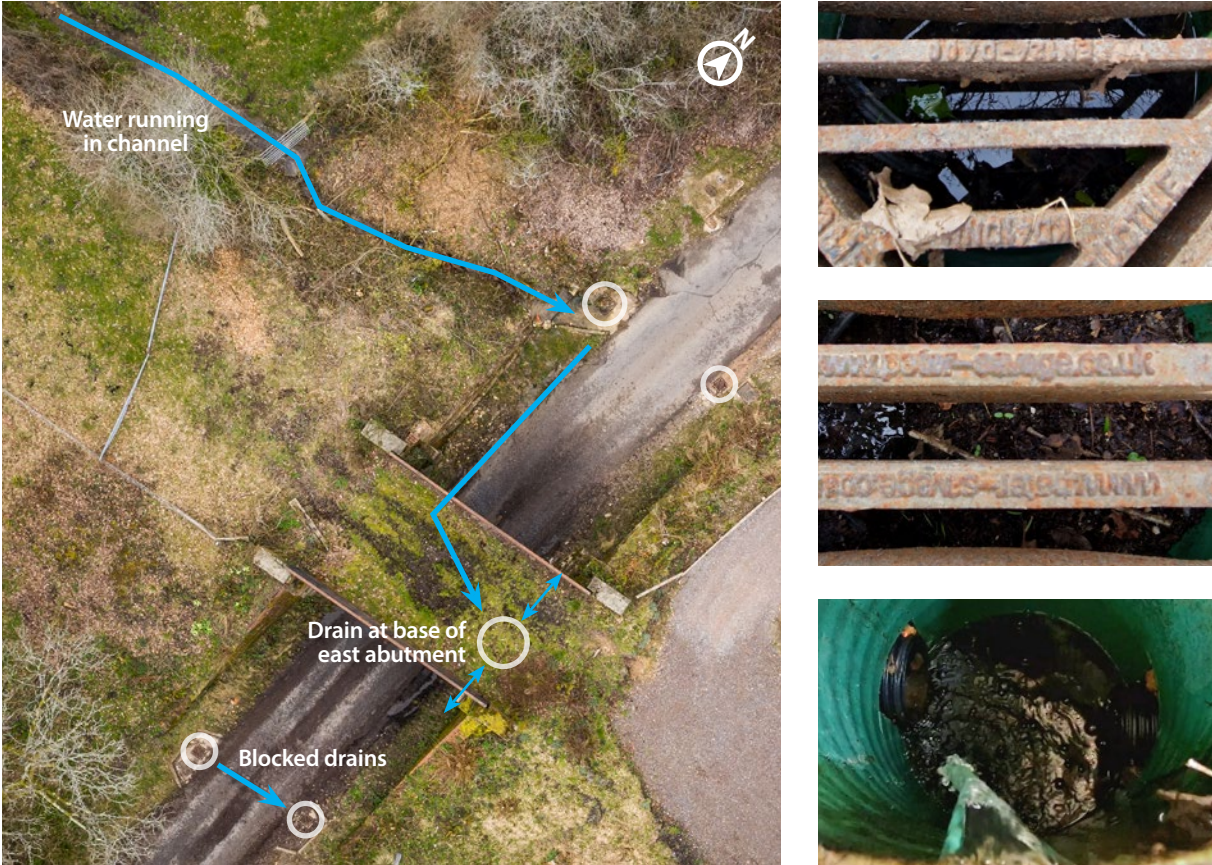
An overview of the bridge drainage system, with additional views into the south-west drain (right upper), south-east drain (right middle) and abutment drain (right lower).

Drains are located close to the lower end of all four wingwalls. Those on the south-side of the bridge appear to be linked, with the western drain observed to be full of water due to the eastern drain being blocked with mud/vegetation.

Pipes connect with the abutment drain from both the north and south. This drain contained water which was not escaping at any discernable rate. We were unable to locate any discharge point for this drainage system and have requested drawings from the highway authority.

We would instead wish to understand the extent to which modifications to the drainage system - or improvements in its maintenance - might help to alleviate the flooding problem.

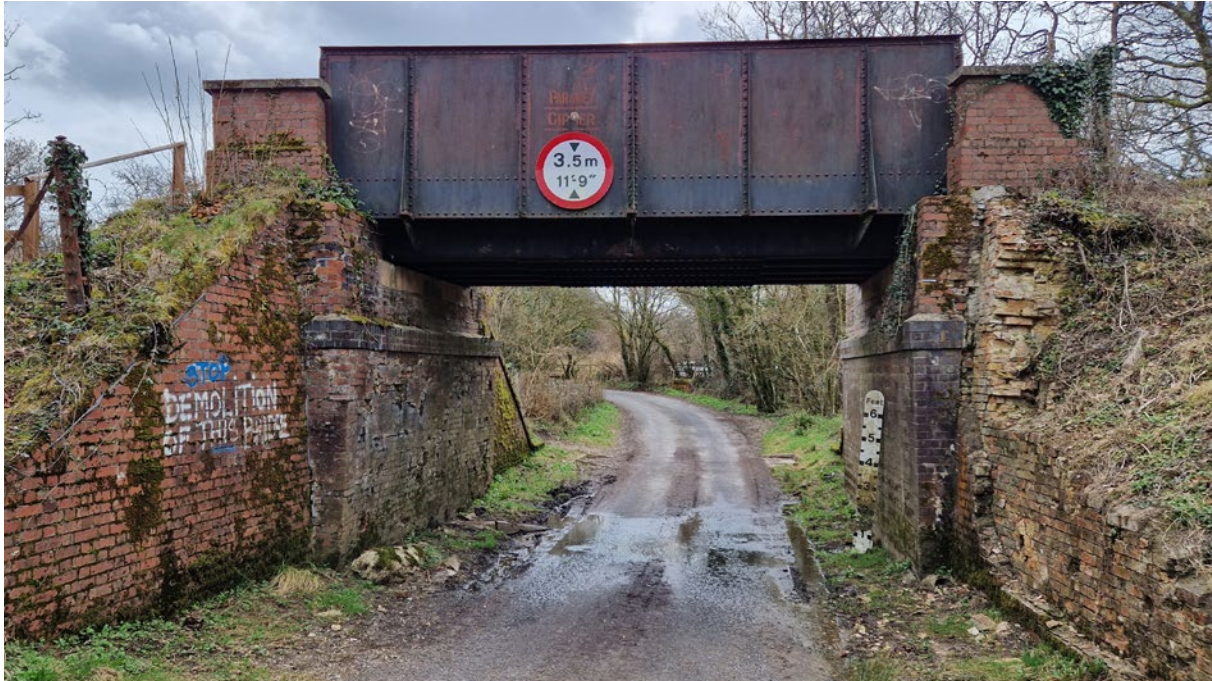
- 1.2. With a single clear span estimated at 6.2m, the bridge has brick abutments and wingwalls. Originally the deck was almost certainly of timber construction, supported onto the string course [brick-on-edge plus 2 courses depth] located around 700mm below the present bridge soffit. Reconstruction with longitudinal metal troughs and solid parapets took place after the GWR took over and replaced the line's timber bridges. The troughs are supported on less substantial brick walls above the string course. Pilasters were probably added at this time. Reconstruction would have increased the headroom to the current 3.5m limit. (See Figure 1)

Figure 1: The bridge's north elevation with sign indicating the height restriction.

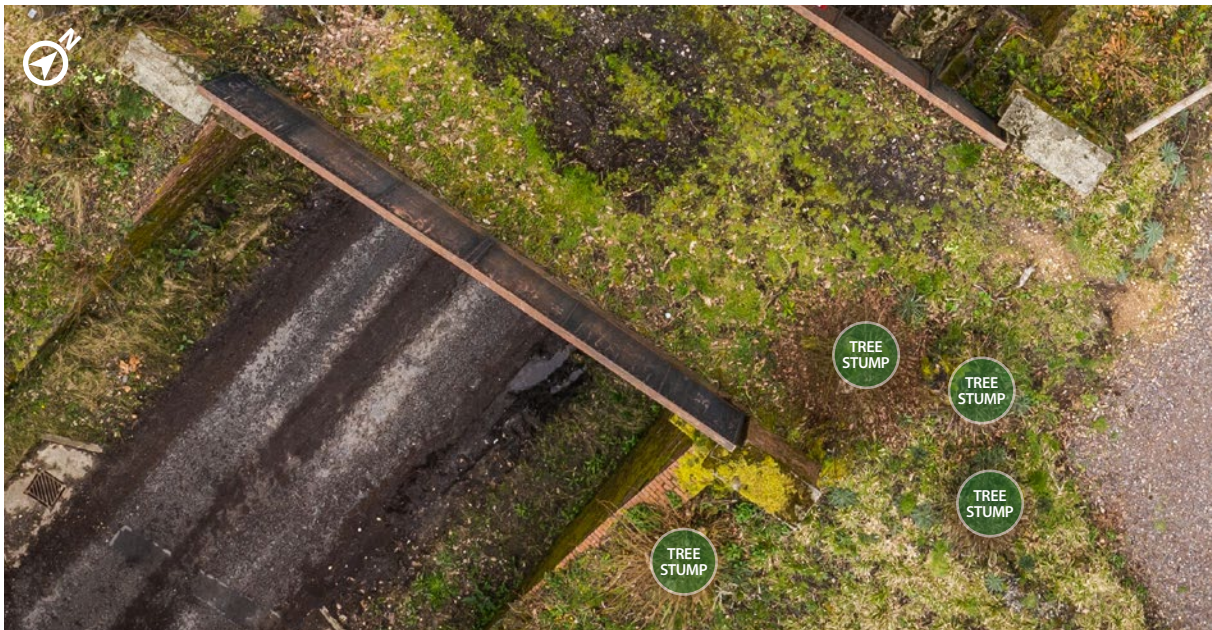
3.1 I noted the presence of mature tree stumps around the bridge, especially at the east abutment, where trees have apparently been recently felled. (See Figure 2)

Figure 2: Plan view of felled trees at east abutment and south-east wingwall.

4.3 Tree stumps around the abutment/wingwall areas should be removed with treatment of exposed roots to prevent future growth.

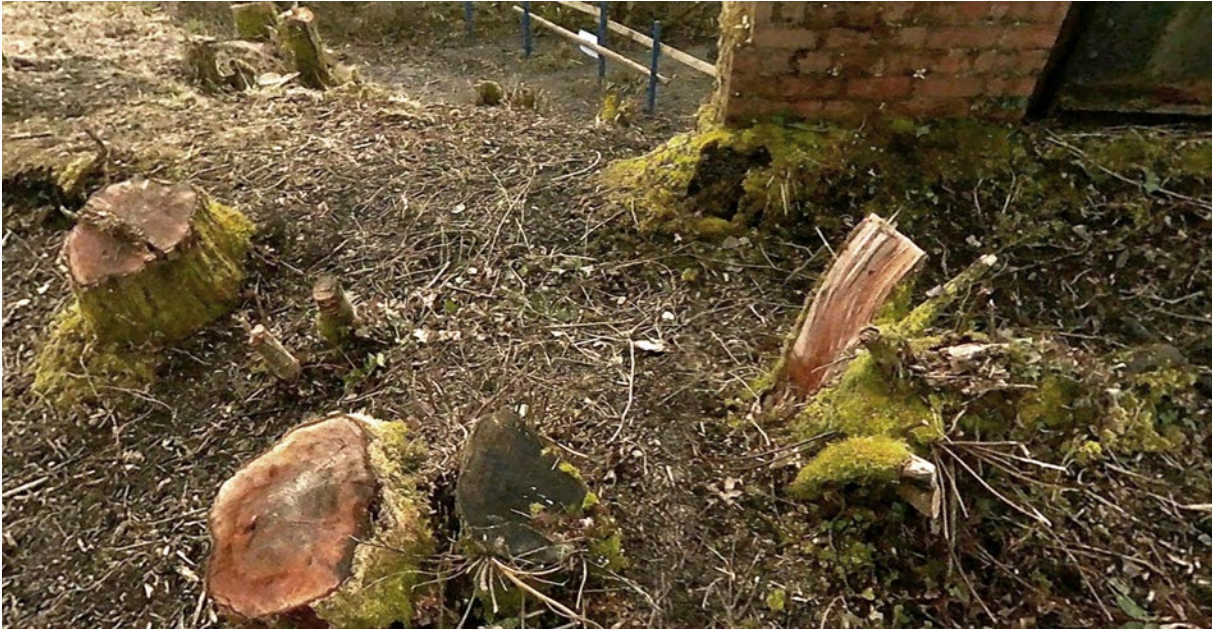
3.2 An inward lean of around 150mm is apparent to the east abutment. Numerous existing 19th Century bridges have leaned abutments, generally due to long term consolidation of ground beneath the foundation toe, but which is rarely critical to overall stability. Usually two abutments supporting a bridge lean by similar degrees. In this case it is strongly suggestive that the east abutment lean has been caused by growth of tree roots expanding against the ground and behind the abutment. (See Figure 3)

Figure 3: Recently felled trees behind the east abutment. (Trevor Streeter)

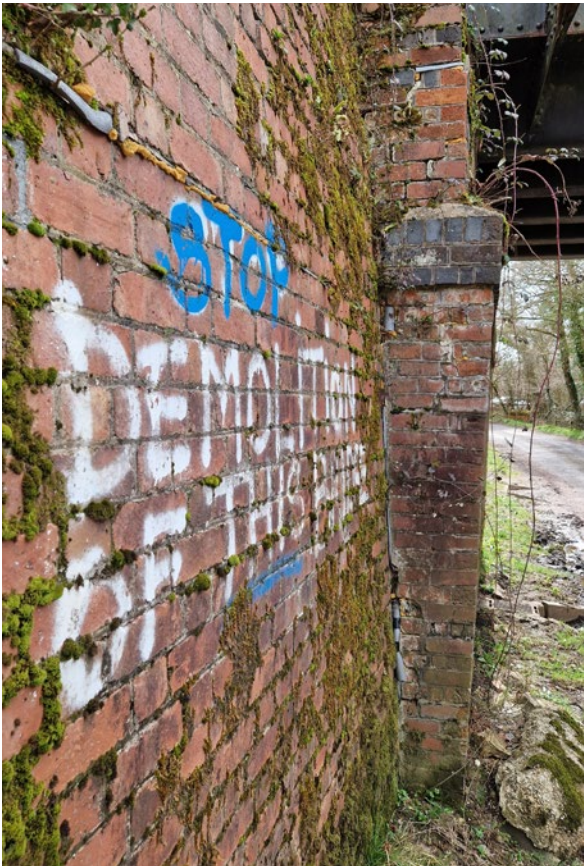
3.3 The wall above the string course supporting the deck to the east abutment is cracked with fractures and is not leaning in sympathy with the abutment. This suggests propping restraint by the deck, but that the wall has been insufficiently rigid to arrest lean of the abutment. (See Figure 4)

Figure 4: Rotation of the east abutment.

4.2 In particular fractured areas should be repaired locally, especially the walls supporting the deck on the east abutment. The north-west wingwall should be rebuilt onto sound existing footings.

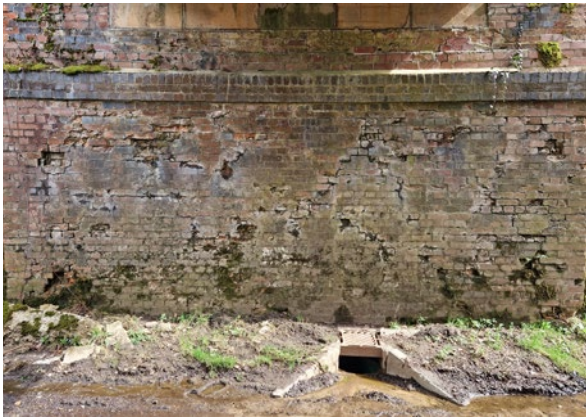
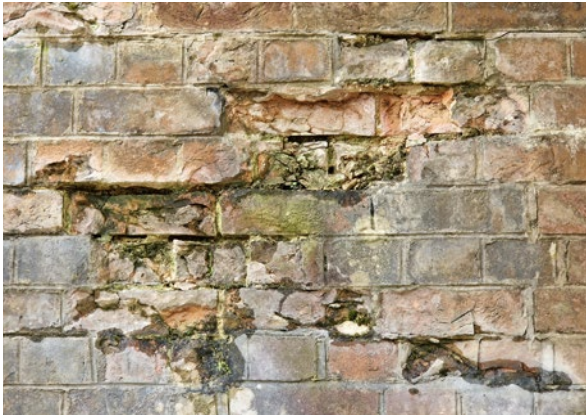
Figure 5: Degradation of the east abutment.

3.4 The east abutment and wingwalls show significant spalling, local cracking, loss of bricks and degradation of brickwork. (See Figure 5) However I see little sign of differential settlement or separation between abutments and wingwalls, indicating that overall integrity of the substructures is intact. Upper parts of the north-west wingwall have collapsed together with loss of front brick face down to road level, apparently due to extensive tree root damage. A photograph from 2011 shows extensive tree growth here. (See Figure 6)

4.1 Remedial works should be considered in conjunction with surveys and any available information such as drawings. Brickwork to the abutments and wingwalls should I consider be repaired by brick replacements and repointing as is necessary to maintain integrity, acceptable appearance and public confidence.

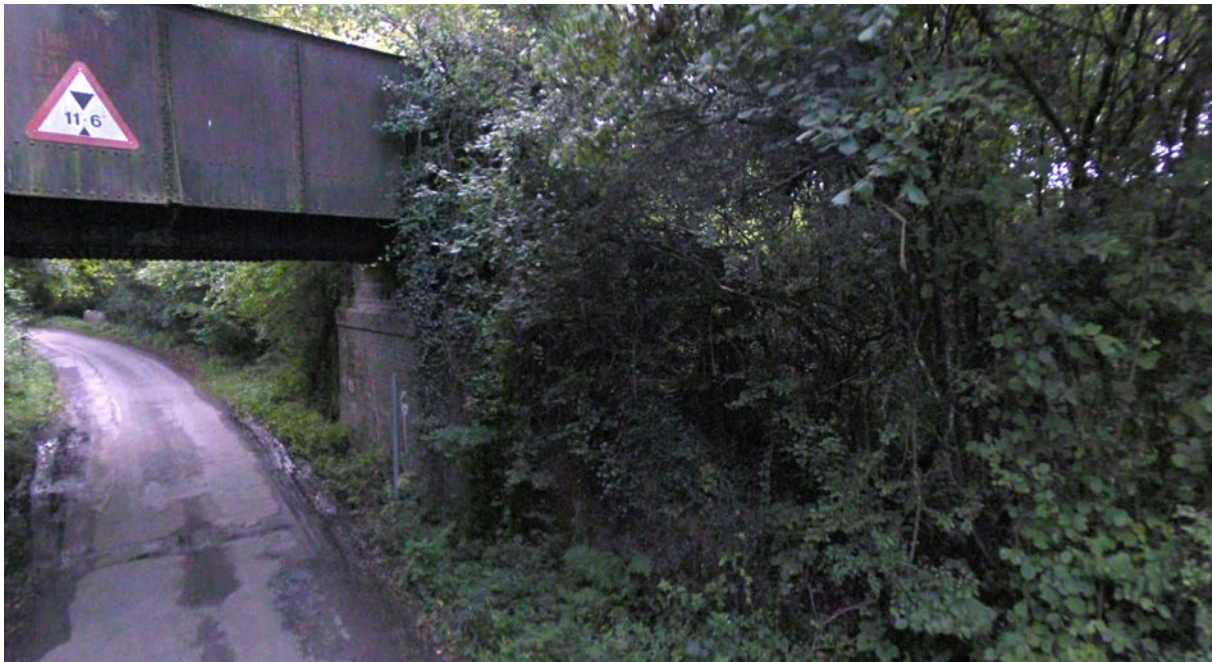
Figure 6: 2011 photograph showing extensive tree growth around the north-west wingwall. (Google Streetview)

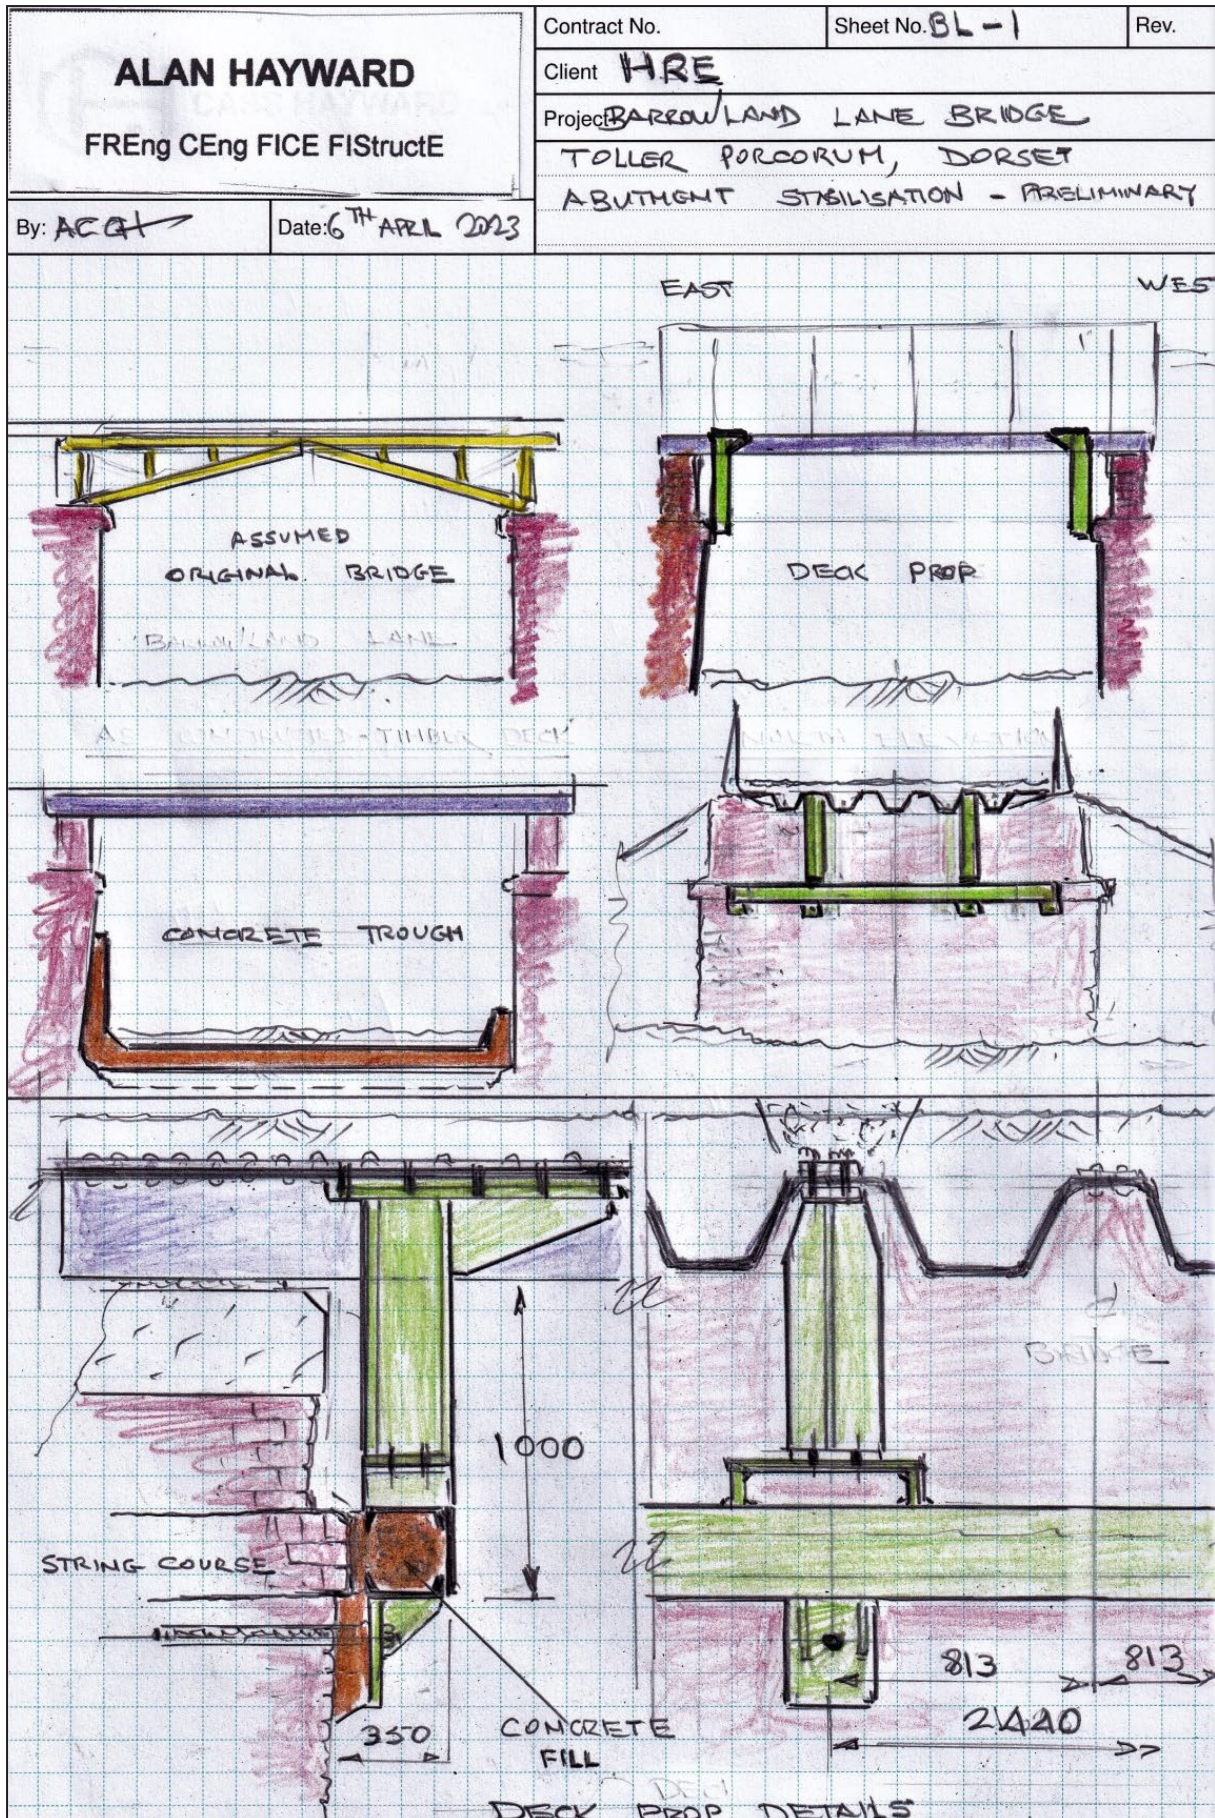
Figure 7: Sketch BL-1 showing two alternatives for stabilisation of the east abutment.

- 5.1 In order to preserve stability of the east abutment stabilisation options should be considered. Sketch BL-1 (See Figure 7) shows two alternatives as in 5.2 and 5.3.

A reinforced concrete trough would be constructed within the roadway, taken up to suitable height to restrain the east abutment. At the west abutment the trough could form a kerb so minimising roadway restriction, or be taken up to height as for the east side. The slab beneath the roadway could incorporate a downstand at each end to prevent floodwater ingress.

Restraint would be achieved by propping at the string course level with steel spreader beams, connected by two brackets at each abutment to the trough deck above. The spreader beams would be secured to the abutment walls and with infill concrete cast against the string course. The brackets would be connected to the trough top flanges with bolting access from above. An indicative calculation shows that troughs with a 12.7mm [0.5 in] thickness would have more than sufficient capacity to resist the forces from "at rest" earth pressures including surcharge. Connection between spreader beam and bracket would incorporate vertical flexibility to allow for deflection of the deck under live loading. This option would minimise restriction to roadway clearance.
