## Executive Summary

**Structure Type:** Single span overbridge

**Assessment Code:** BD21/01

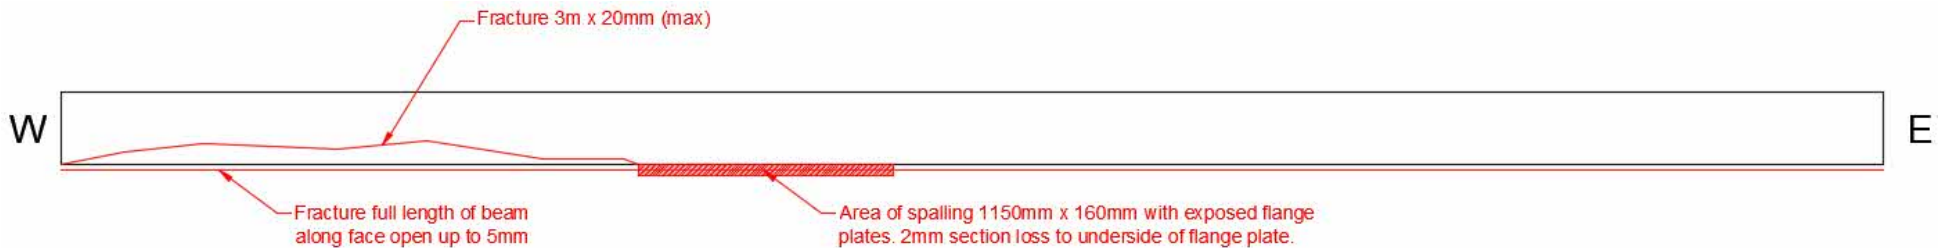
Figure 3. Plan View of Beam No.1 Defects (Photograph 7)

The north edge beam (Beam No.1) is in fair condition with the following visible defects noted during the deck soffit inspection:

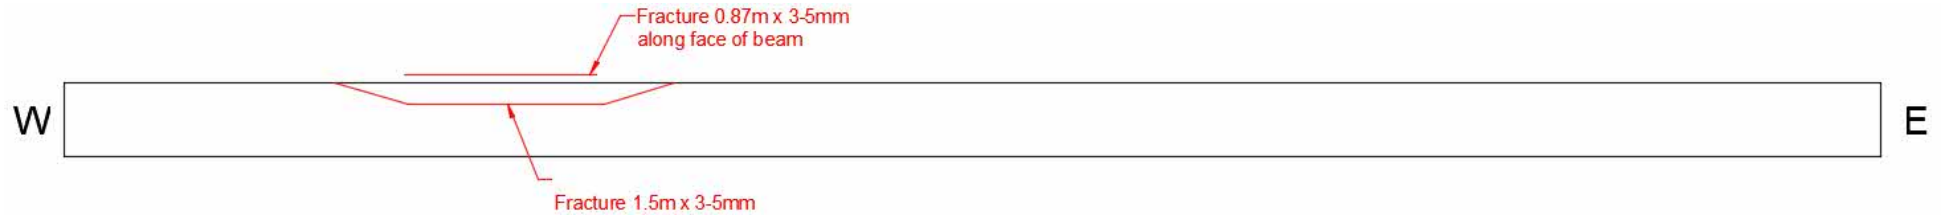
Figure 4. Plan View of Beam No.7 Defects (Photograph 13)

The south edge beam (Beam No.7) is in fair condition with the following visible defects noted during the deck soffit inspection:

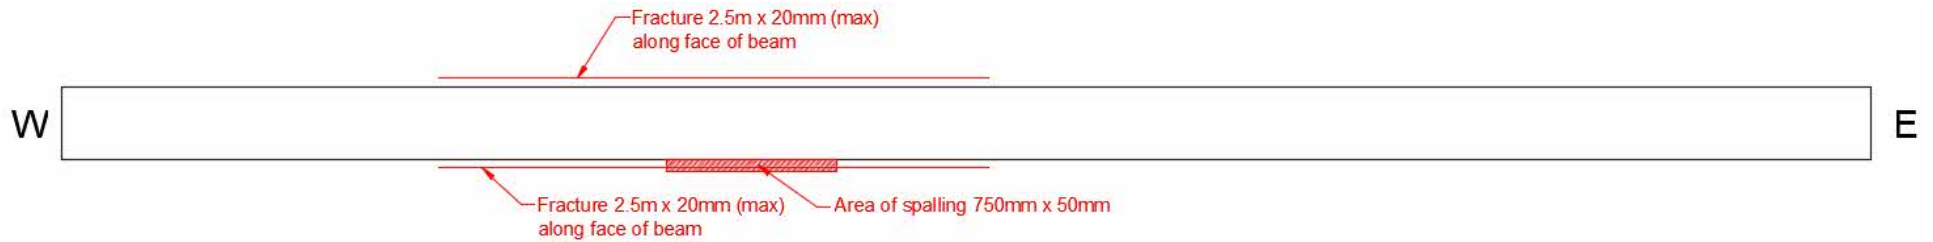
Figure 5. Plan View of Beam No.2 Defects (Photograph 8)

The internal beams are in fair condition with the following visible defects noted during the deck soffit inspection:

All areas of exposed flange plates exhibit up to 2mm section loss due to corrosion to the underside of the bottom plate. These areas are situated within areas of damp visible across the underside of the concrete encasement. Cracking through the concrete encasement is evident along each beam with spalling to the surrounding concrete occurring when tapped with a hammer.
