| ELR: | EDE | Structure No.: | 25 | Mileage: | 4m 10ch | Examination Date: | 22/01/2021 |
| Name: | Great Musgrave | | | | | Type: | OB |

| General View of Structure: North Elevation | Preliminaries |

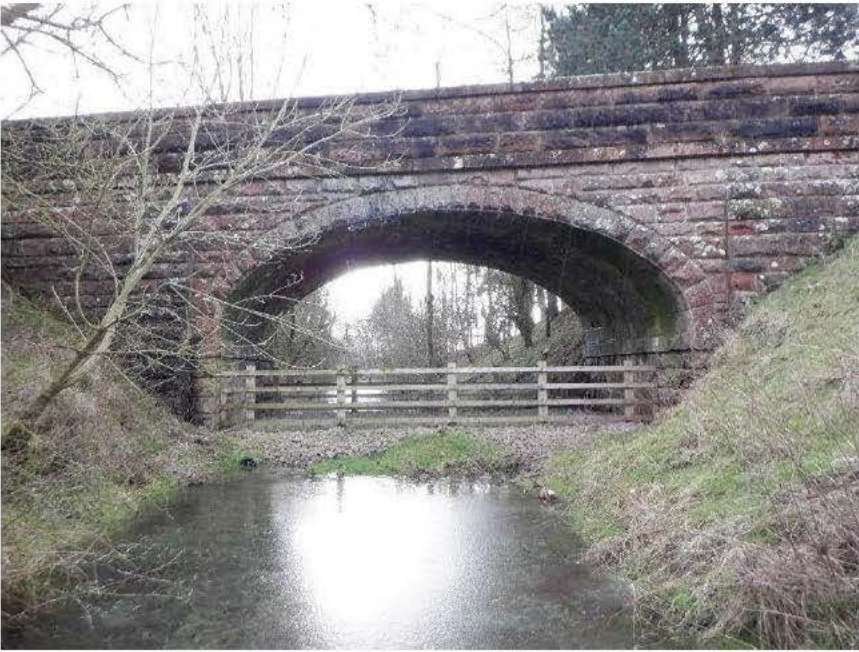
| <p>General Comments by the Examiner:</p> <ul style="list-style-type: none"> • The bridge appears to be in fair condition. • General masonry repairs required to the arch soffit. • Bridge bash damage requires attention. • Approach walls require repairing. |

| <p>Recommendations (by the Examining Engineer):</p> <p>Take down & rebuild the bridge bash damaged SE wingwall parapet £3k - P1.</p> <p>Repair two drystone approach walls £5k - P1.</p> <p>General masonry repairs to the arch soffit including repoint DOJ's and stitch & grout displaced blocks as necessary £50k - P1.</p> <p>Fit Highways Act 1980 "not a dedicated way" signs to each elevation £500 - P1.</p> <p>Signed: </p> <p>STE2/STE6 Examining Engineer: </p> |
