Great Musgrave EDE/25

Report for The HRE Group

Revision A, 9 May 2022

BILL HARVEY ASSOCIATES LTD.

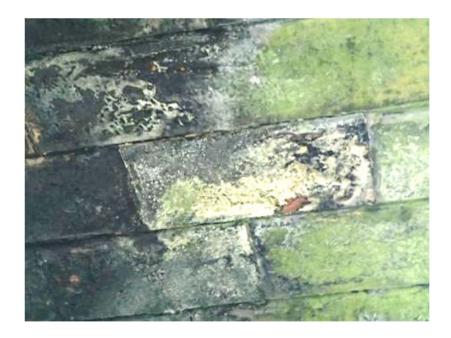
Photos 11-13, "Example of long-standing downward alignment defects."

Figure 2.2: Photo 12 from 2020 visual, showing dropped stone. Quality is limited but exposed edge does not look at all different. We would expect a cleaner face in a recently dropped stone, and abrasion or damage in a stone dropping due to mechanical stone dropping due to mechanical action.

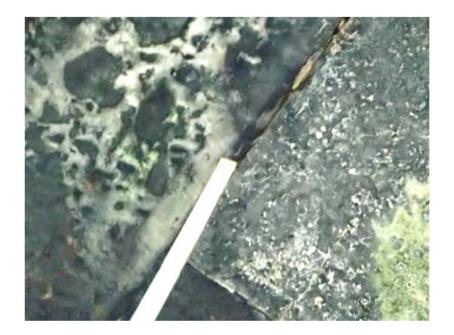
Figure 2.3: Photo 13 from 2020 visual, showing dropped stone with ruler. Ruler sits within chamfer at corners of stones. Where and how was the drop measured on each occasion?

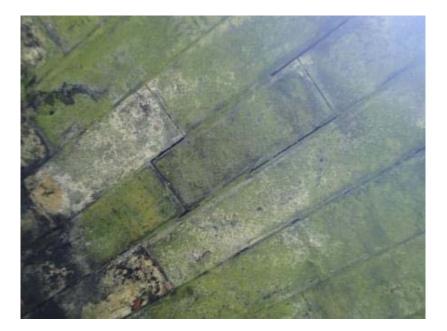
Figure 2.4: Example of open joints, presented as photo 14 in 2020 visual inspection report. The voids are over limited lengths of joint; there remains ample area to carry the thrust.

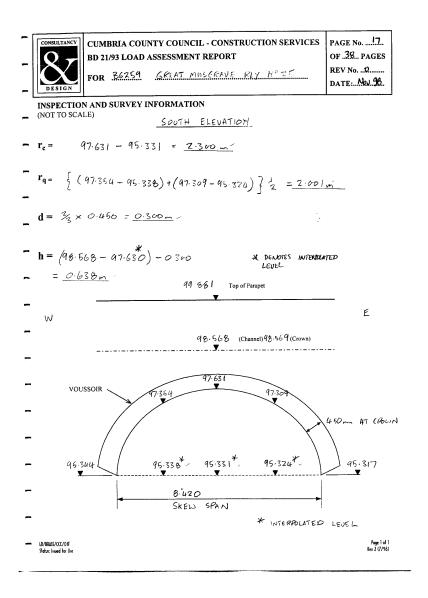
Figure 4.3: South elevation dimensions from 1998 assessment report.

Figure 4.3 shows the south elevation dimensions. These are shown as levels, measured at the springings, quarter points, and crown.

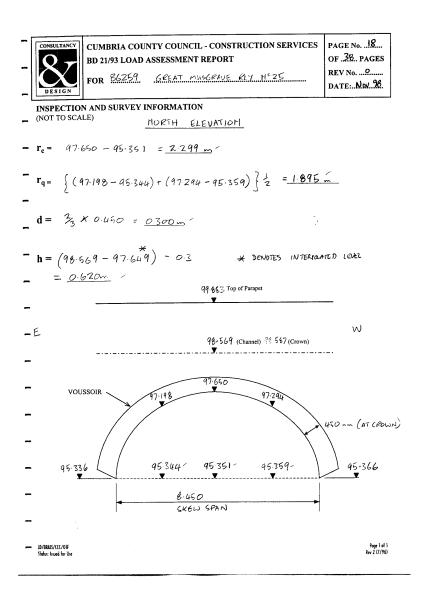
Figure 4.4: North elevation dimensions from 1998 assessment report.

Looking now at the north elevation, dimensions in figure 4.4, things get less convincing. The 20 mm difference in level between the abutments is repeated here, but a drop of this scale across the span would show as distress in the spandrel wall masonry. A 20 mm level difference between elevations is also suggested, and

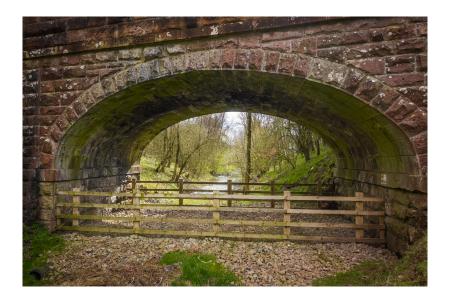
Figure 5.1 gives a view of the elevation and soffit. The water marks suggest backing at least to the sixth voussoir from the end but more likely the ninth, which would be more or less level with the arch crown intrados.

Figure 5.1: A recent photograph showing elevation and soffit.

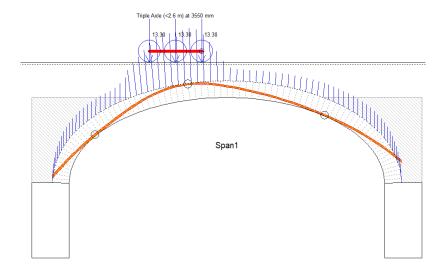
Figure 5.2: Worst case AWR load for Great Musgrave geometry, with backing to crown intrados level.

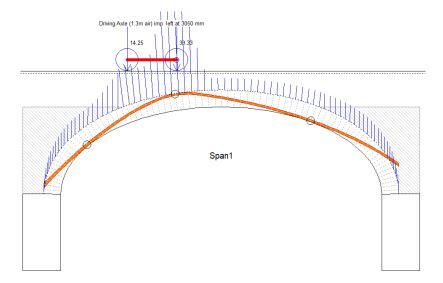
Figure 5.3: Worst case AWR load with impact for Great Musgrave geometry, with backing to crown intrados level.

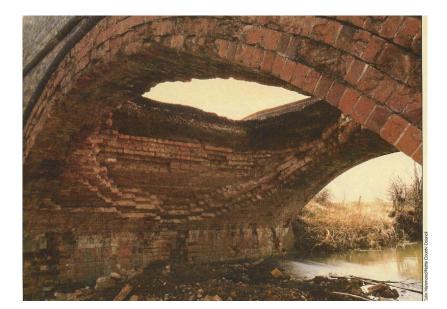
Figure 6.1: A masonry bridge in which the arch ring dropped out.

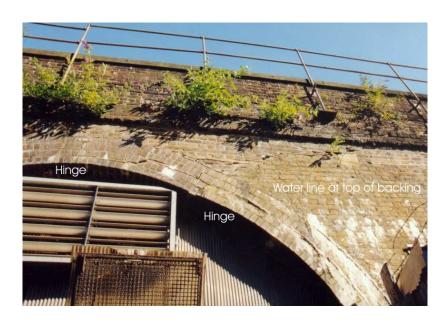
Figure 6.3: Damage resulting from a pier dropping around 100mm. The structure continued to carry rail traffic without risk of collapse.

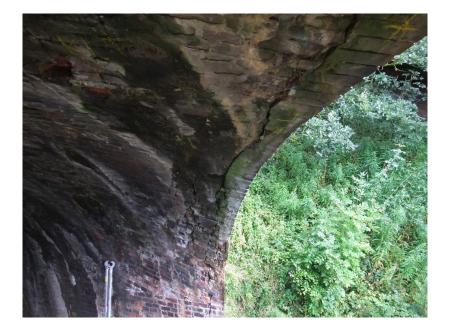
Figure 6.4: Damage to brick bridge at Great Dunchurch. Cyclic live loads have caused a crack to develop through the ring where the spandrel wall stiffens the edges.

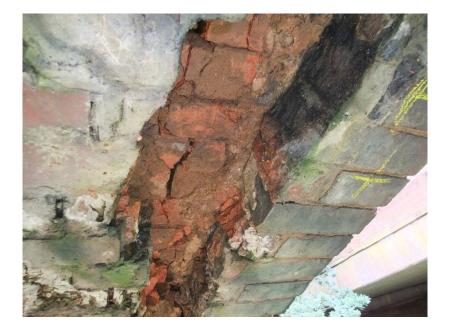
Figure 6.5: Here, the crack has bifurcated, creating an island patch which has then fallen out.

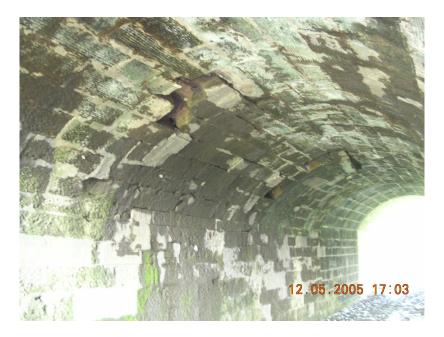
Figure 6.6: Severe damage to a bridge, with stones dropping due to mechanical action.

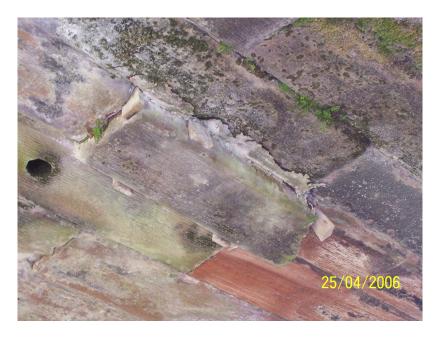
Any one stone could only drop as far as the neighbouring stones allowed. Figure 6.7 shows how spalling of the next stone is required to allow further movement.

Figure 6.7: A single dropped stone due to mechanical action. Note the clear damage to the surrounding stone, without which the stone could not have dropped this far.
