## Ref APP/V2635/C/24/3336603: Infilling of St Andrew's Lane bridge, Congham

This representation relates to National Highways' (NH) appeal against the Enforcement Notice that was issued following the refusal of its retrospective planning application (ref 23/00894/F) which sought permission to retain infill at the bridge carrying St Andrew's Lane over the dismantled Midland & Great Northern Joint Railway (M&GNJR) at Congham, Norfolk.

PMY2/76 BD21 Assessment and Inspection Report

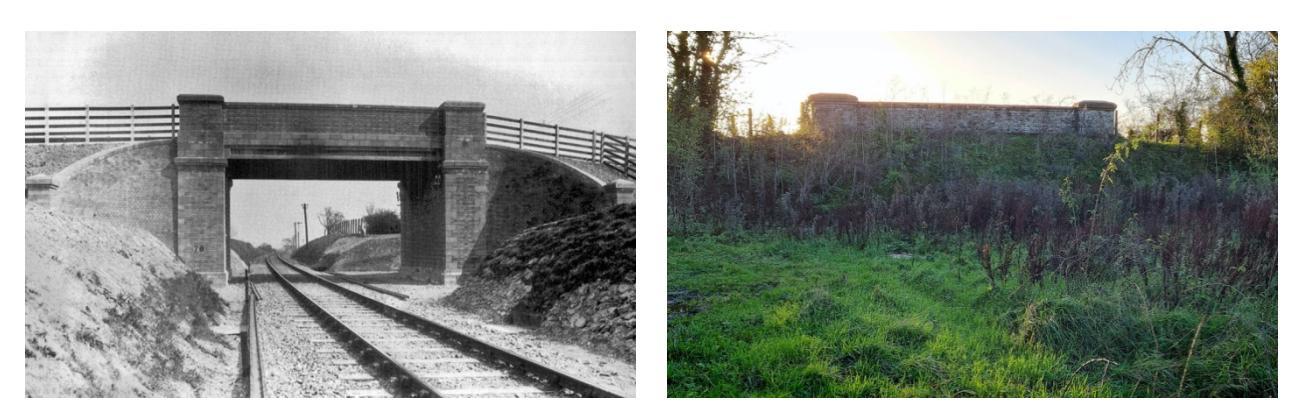
An early photograph of the bridge carrying St Andrew's Lane (M&GN Trust) and a similar view captured in 2022.

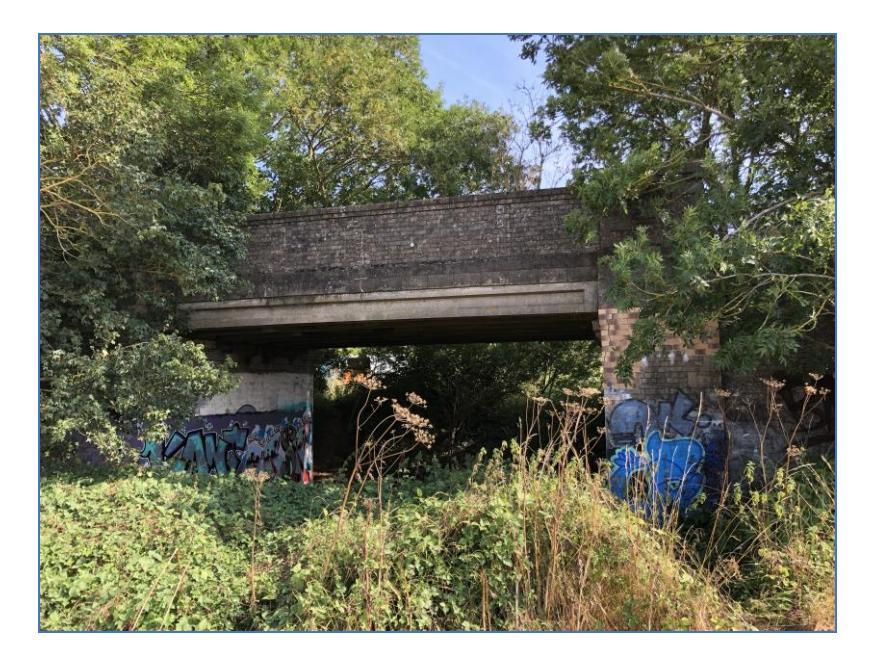
#### Image 1 - View of south elevation access below structure

The bridge has been subject to a series of structural assessments. The most recent was in 2019 which was undertaken by Jacobs on behalf of HRE. The assessment concluded that the edge girders are restricted to a 7.5 Gross Vehicle Weight (GVW). Furthermore, the eastern abutment is exhibiting indications of movement, resulting in numerous cracks appearing beneath the edge girders and along the abutment faces. The faces of the longitudinal girders are also showing defects with some beam exposure in some instances. The wingwall coping courses and the

south west newel are demonstrating minor failure and collapse, which could be caused by the dense vegetation present on all embankments.

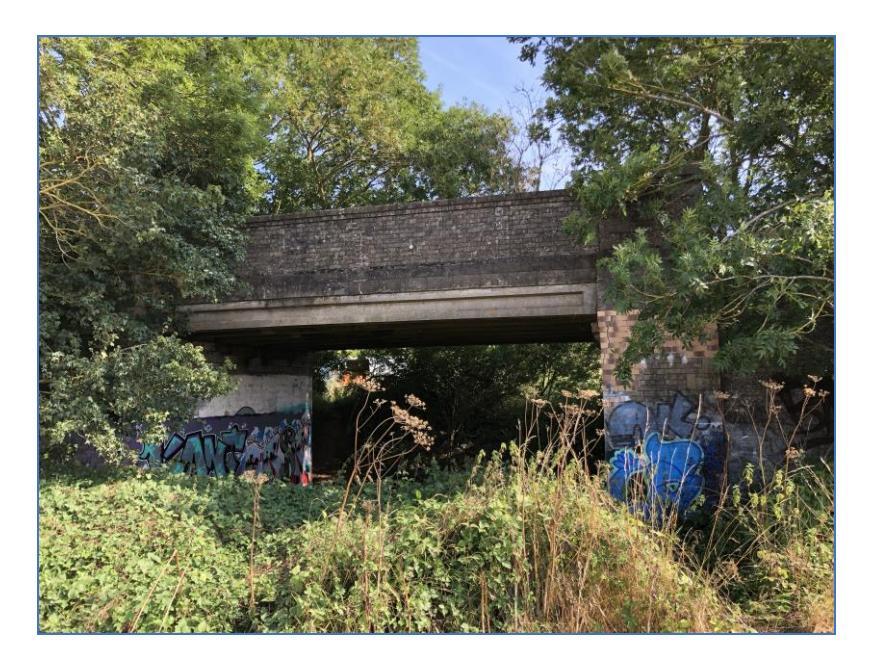
#### Image 1 - View of south elevation access below structure

The bridge has been subject to a series of structural assessments. The most recent was in 2019 which was undertaken by Jacobs on behalf of HRE. The assessment concluded that the edge girders are restricted to a 7.5 Gross Vehicle Weight (GVW). Furthermore, the eastern abutment is exhibiting indications of movement, resulting in numerous cracks appearing beneath the edge girders and along the abutment faces. The faces of the longitudinal girders are also showing defects with some beam exposure in some instances. The wingwall coping courses and the

south west newel are demonstrating minor failure and collapse, which could be caused by the dense vegetation present on all embankments.

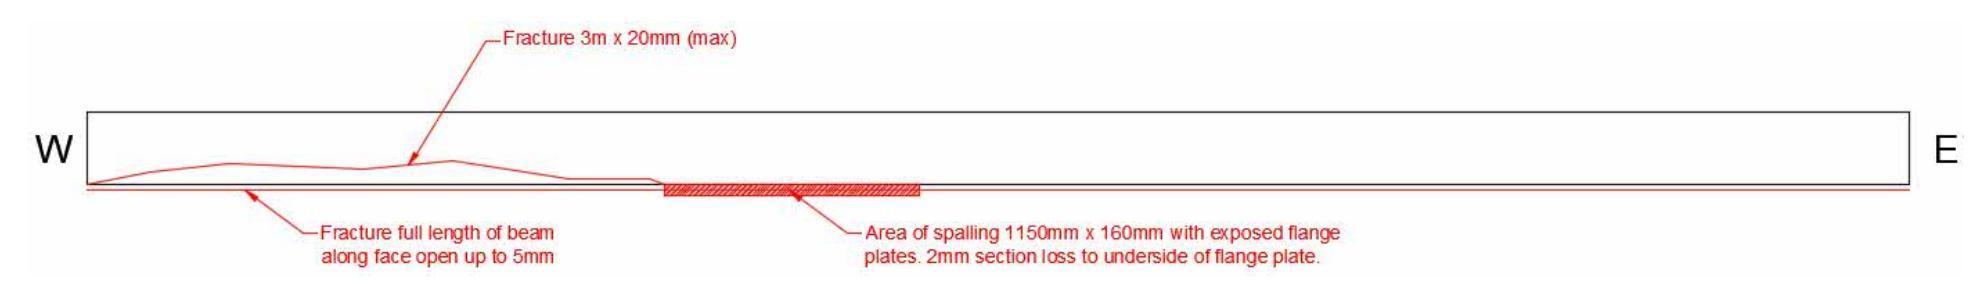
Figure 3. Plan View of Beam No.1 Defects (Photograph 7)

The north edge beam (Beam No.1) is in fair condition with the following visible defects noted during the deck soffit inspection:

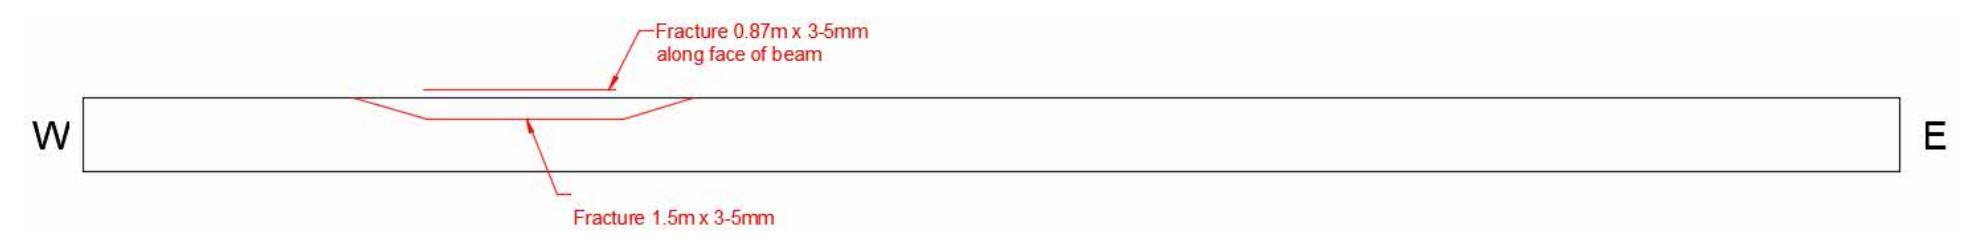
Figure 4. Plan View of Beam No.7 Defects (Photograph 13)

The south edge beam (Beam No.7) is in fair condition with the following visible defects noted during the deck soffit inspection:

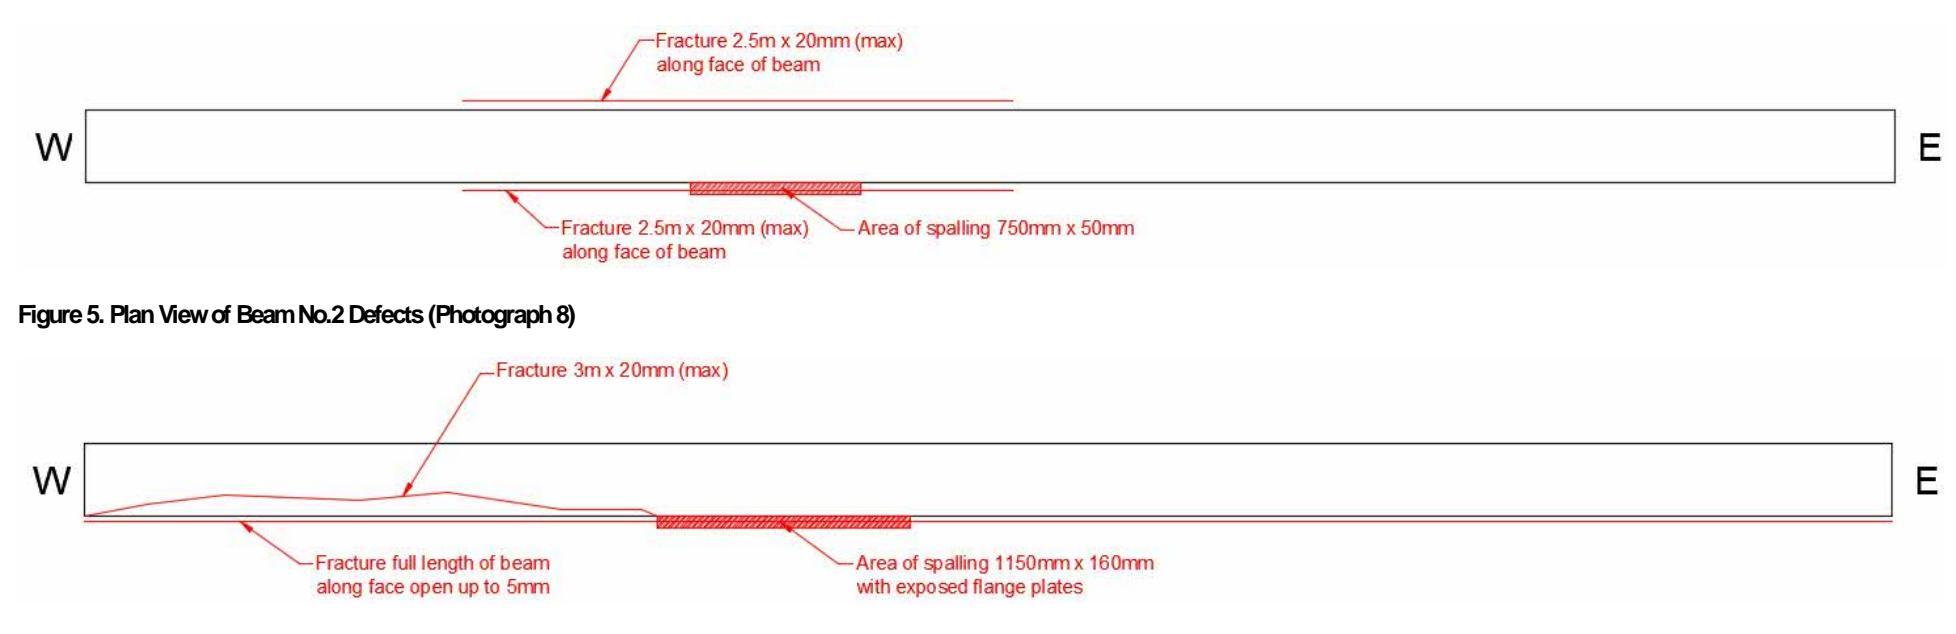
Figure 6. Plan View of Beam No.3 Defects (Photograph 9)

The internal beams are in fair condition with the following visible defects noted during the deck soffit inspection:

All areas of exposed flange plates exhibit up to 2mm section loss due to corrosion to the underside of the bottom plate. These areas are situated within areas of damp visible across the underside of the concrete encasement. Cracking through the concrete encasement is evident along each beam with spalling to the surrounding concrete occurring when tapped with a hammer.
