# Great Musgrave EDE/25

*Report for The HRE Group*

*Revision A, 9 May 2022*

Great Musgrave Bridge is a single span masonry bridge carrying a minor road over the trackbed of the former Eden Valley Railway (EDE). The structure number is EDE/25.

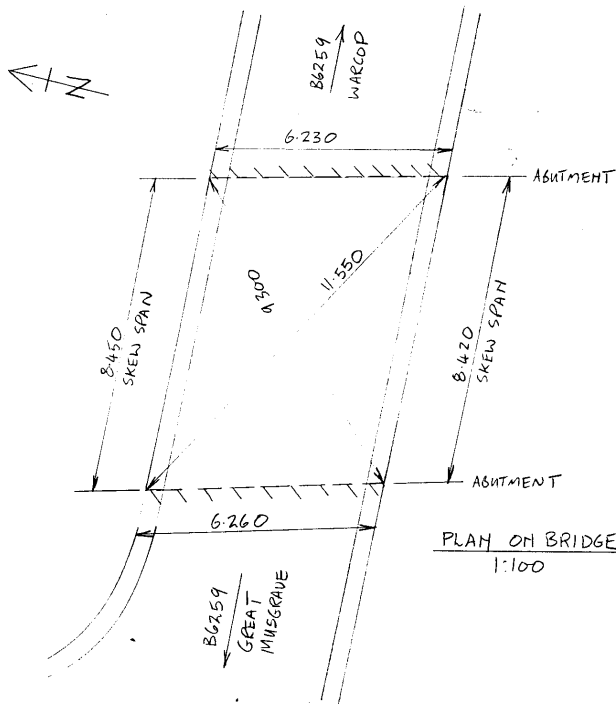
Figure 4.2: Plan dimensions from 1998 assessment report.

Figure 4.2 gives plan dimensions, with widths at each abutment, skew span at each elevation, and both diagonals.

Thus the centres were 27 foot span and placed square to the abutments.
