14 April 2023

## BRP/8 Barrowland Lane bridge, near Toller Porcorum, Dorset

## **BRP/8 Barrowland Lane bridge: Engineering Appraisal**

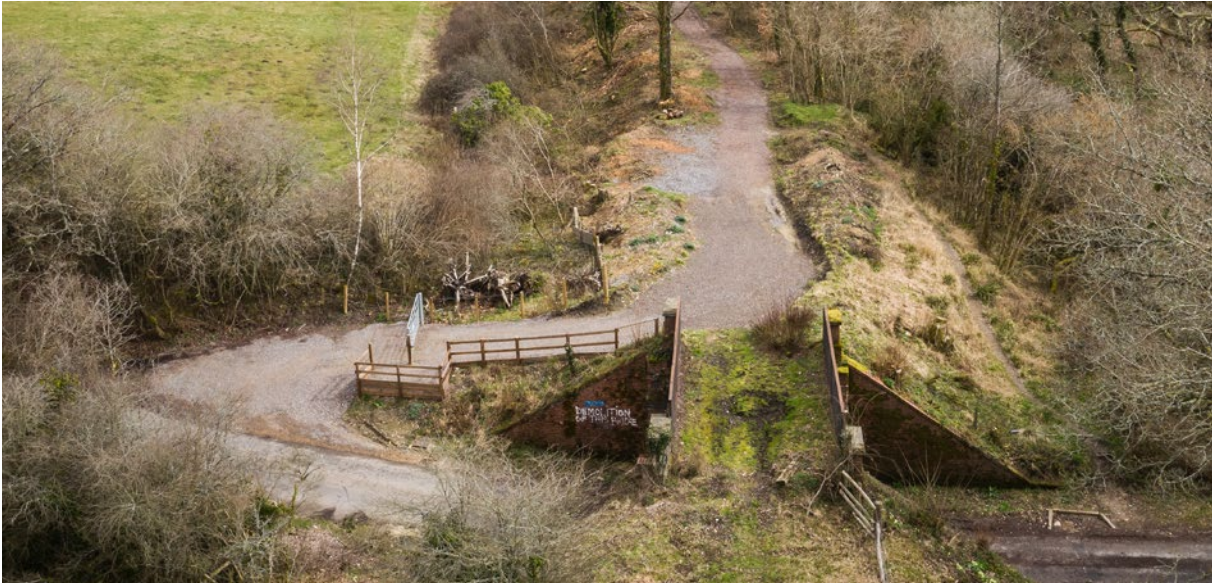
The existing 'temporary' ramp from Barrowland Lane onto the railway is located on the north side of the eastern approach embankment and was used by one walker, one cyclist and two horseriders during our visit. Although it is steeper than the maximum 1:20 gradient recommended in LTN 1/20 (guidance for local authorities on designing high-quality, safe cycle infrastructure), the ramp only extends for approximately 40 feet. Simple and minor realignment works could be undertaken to further ease the gradient if such a need is identified.

*The existing 'temporary' ramp onto the railway that connects the nature reserve to Toller Porcorum.*

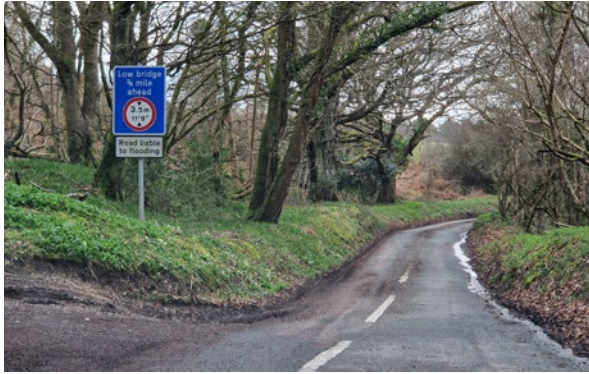
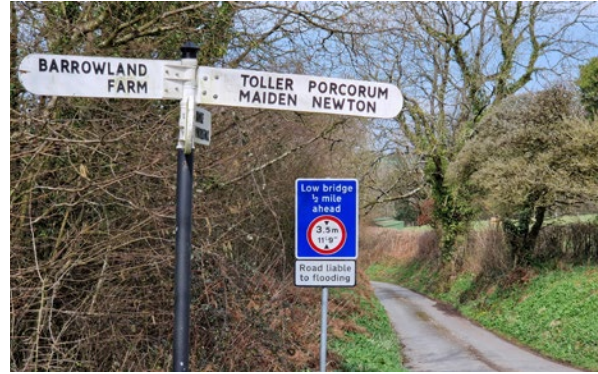
Photos showing the width of Barrowland Lane at the entry/exit points of an alternative route via Toller Porcorum.

It is also noted that trees overhanging the road on both approaches to the bridge restrict vehicle height. Barrowland Lane is very narrow in places and not suitable for large vehicles. The road extends for approximately 1.2 miles between the entry/exit points of an alternative route of approximately 2.8 miles via Toller Porcorum.
