Great Musgrave EDE/25

Report for The HRE Group

Revision A, 9 May 2022

BILL HARVEY ASSOCIATES LTD.

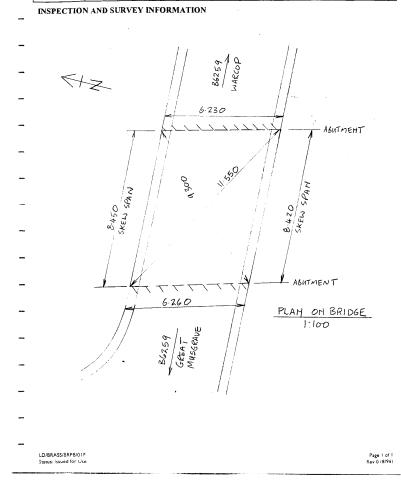
Figure 4.2 gives plan dimensions, with widths at each abutment, skew span at each elevation, and both diagonals.

Figure 4.2: Plan dimensions from 1998 assessment report.
