BRIDGE ASSESSMENT TO BD21/97

B6259 - GREAT MUSGRAVE RAILWAY BRIDGE NO 25

BD 21/97 LOAD ASSESSMENT REPORT

ELR:	EDE	Structure No:	25	Mileage:	Examination date:	08/02/20
Route:	Eden	Valley Jn - Kirkby	Stephen ((Warcop Branch)	OS ref: NY 765 130	6
Name:	Great	Musgrave			Type: Over bridge

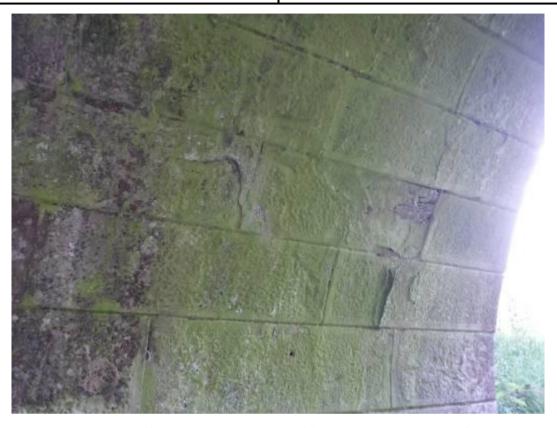
Photo No.7: Arch ring soffit: Erosion with loss of face to stonework at N/W haunch area.

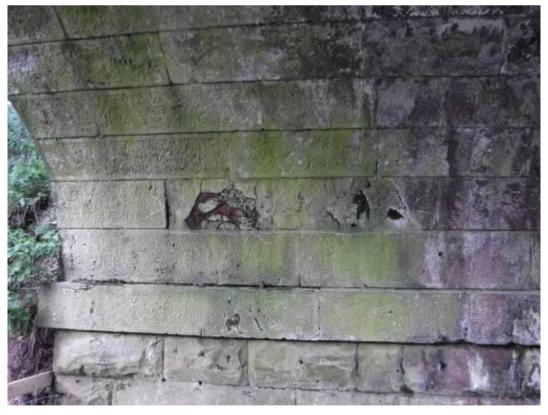
Photo No.8: Arch ring soffit: Erosion with loss of face to stonework at S/W haunch area.

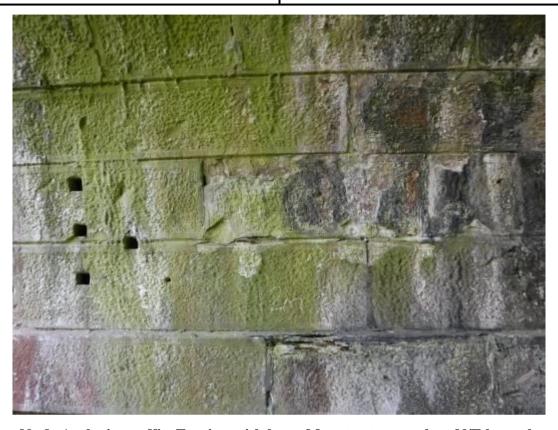
Photo No.9: Arch ring soffit: Erosion with loss of face to stonework at N/E haunch area.

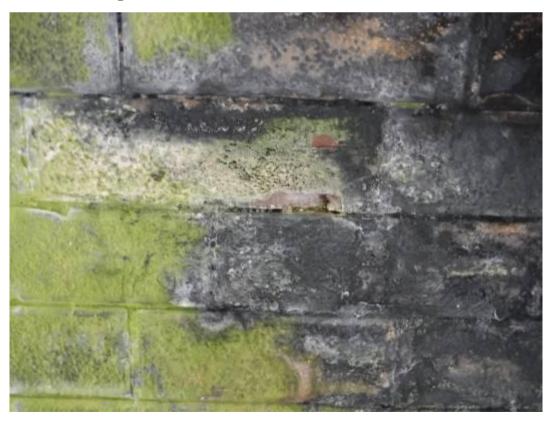
Photo No.10: Arch ring soffit: Loss of stonework to the N/E crown region.

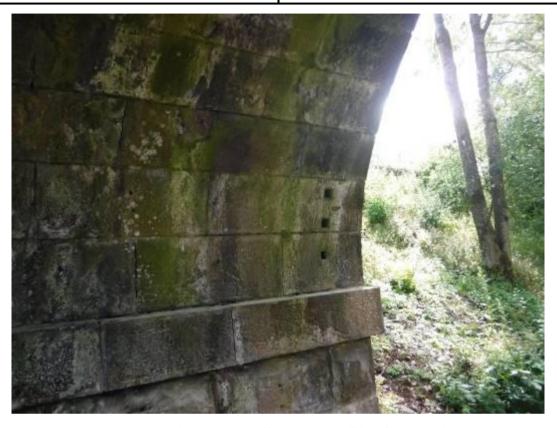
Photo No.13: Arch ring soffit: Former S&T fixing voids.

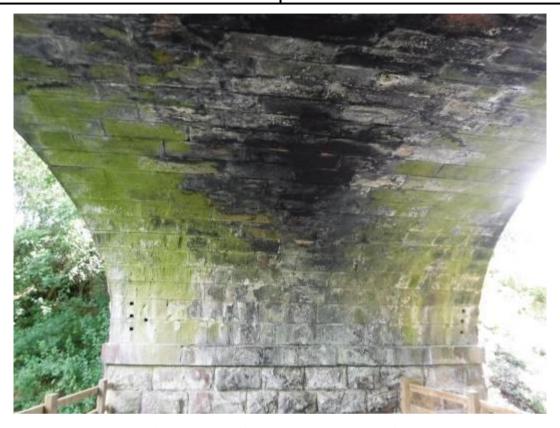
Photo No.15: Arch ring soffit: Typical example of the condition.

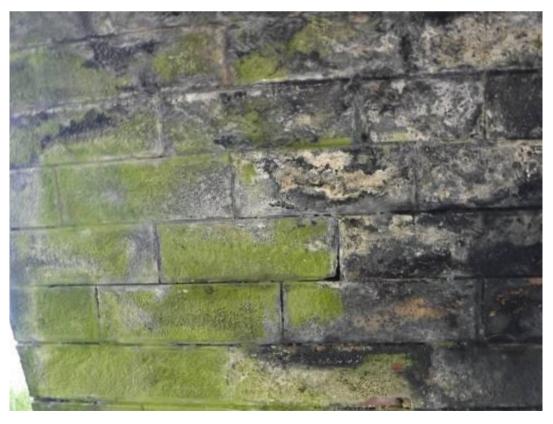
Photo No.16: Arch ring soffit: Typical example of the condition.

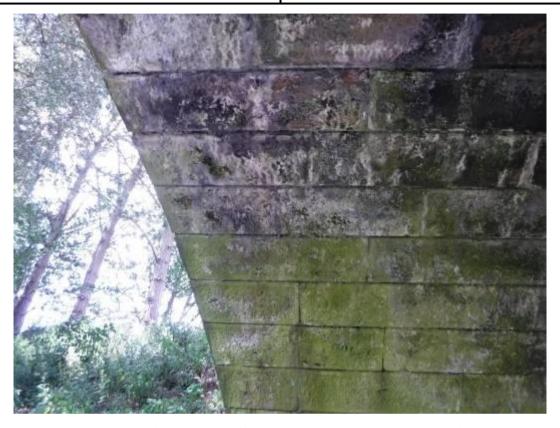
Photo No.17: Arch ring soffit: Typical example of the condition.

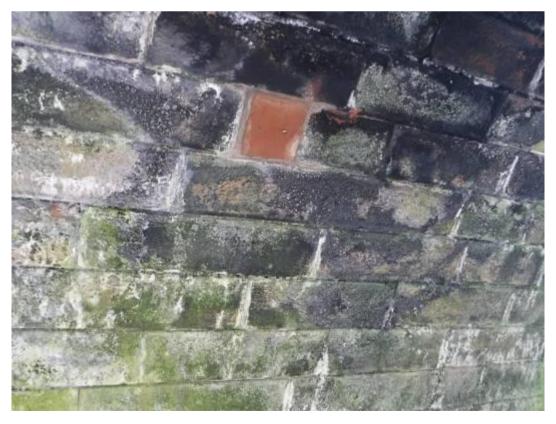
Photo No.18: Arch ring soffit: Typical example of the condition.

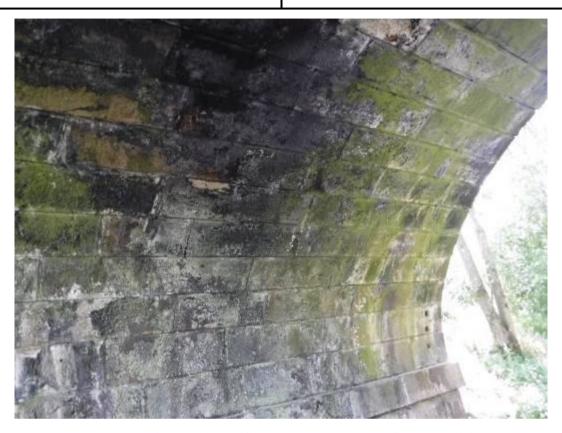
Photo No.19: Arch ring soffit: Typical example of the condition.

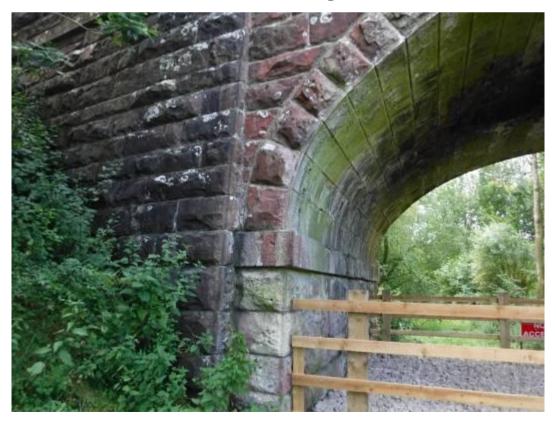
Photo No.22: North arch ring face: Typical example of the condition.

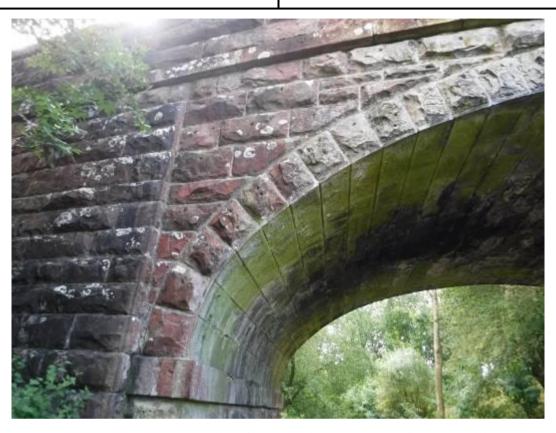
Photo No.23: North arch ring face: Typical example of the condition.

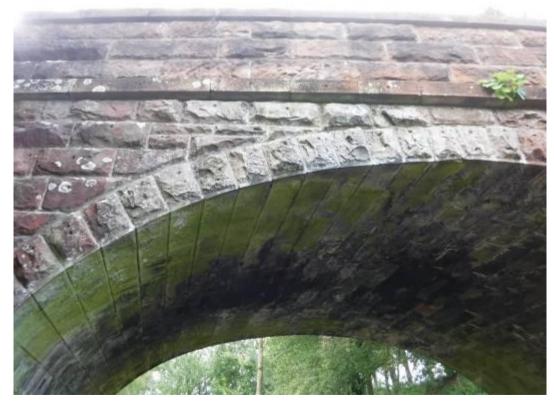
Photo No.24: North arch ring face: Typical example of the condition.

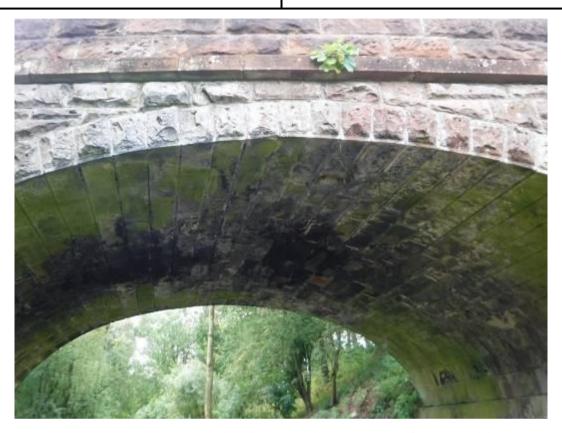
Photo No.25: North arch ring face: Typical example of the condition.

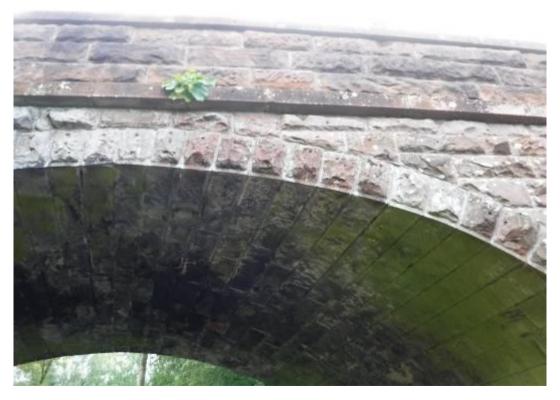
Photo No.26: North arch ring face: Typical example of the condition.

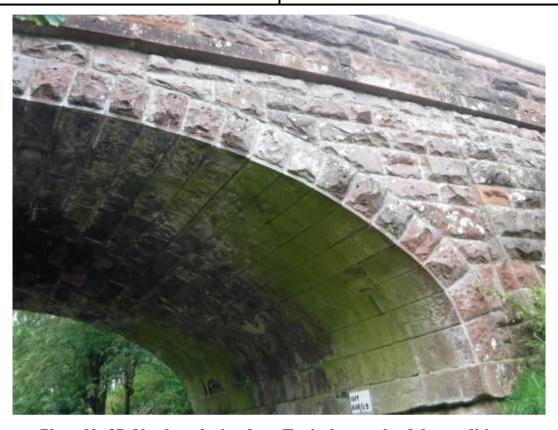
Photo No.27: North arch ring face: Typical example of the condition.

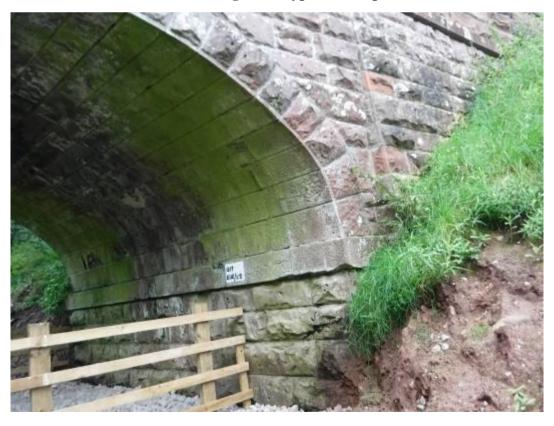
Photo No.28: North arch ring face: Typical example of the condition.

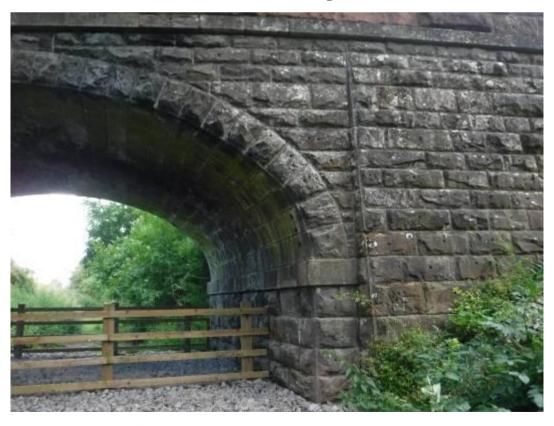
Photo No.30: South arch ring face: Typical example of the condition.

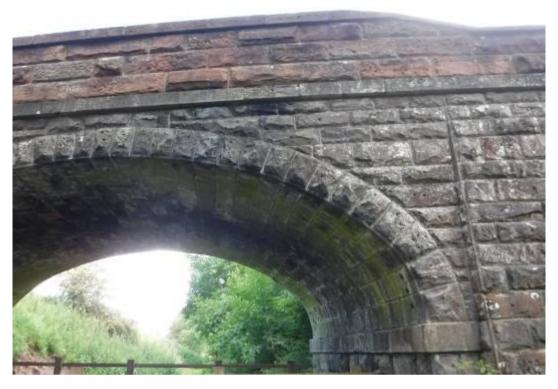
Photo No.31: South arch ring face: Typical example of the condition.

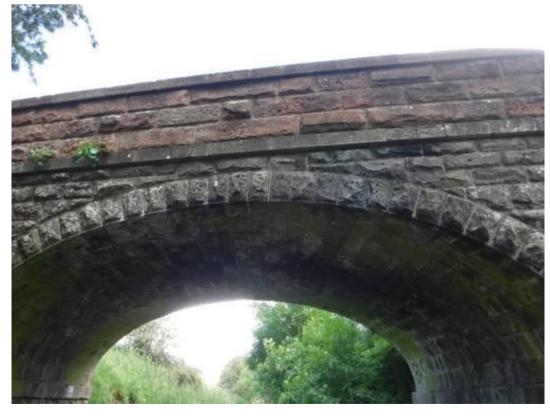
Photo No.32: South arch ring face: Typical example of the condition.

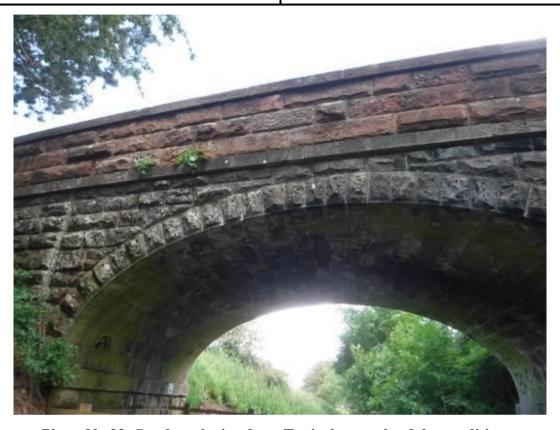
Photo No.33: South arch ring face: Typical example of the condition.

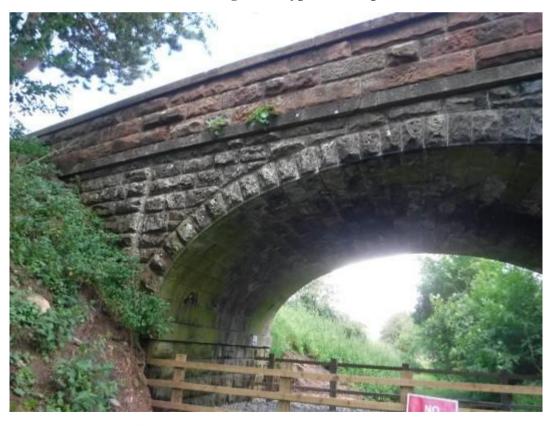
Photo No.34: South arch ring face: Typical example of the condition.

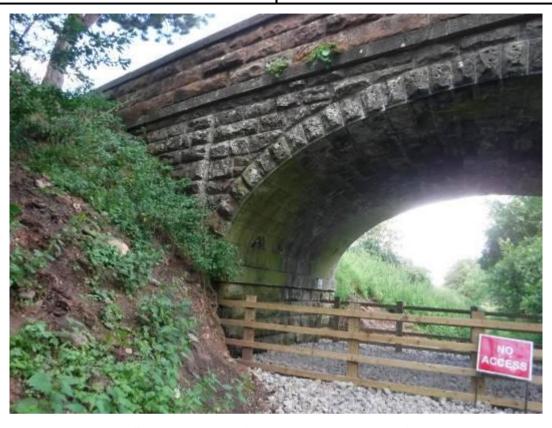
Photo No.35: South arch ring face: Typical example of the condition.

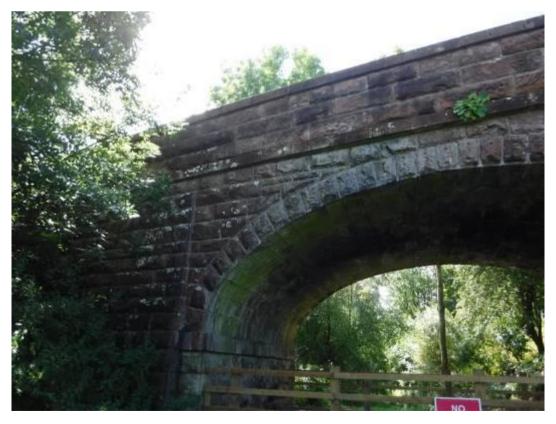
Photo No.36: North spandrel: N/E view.

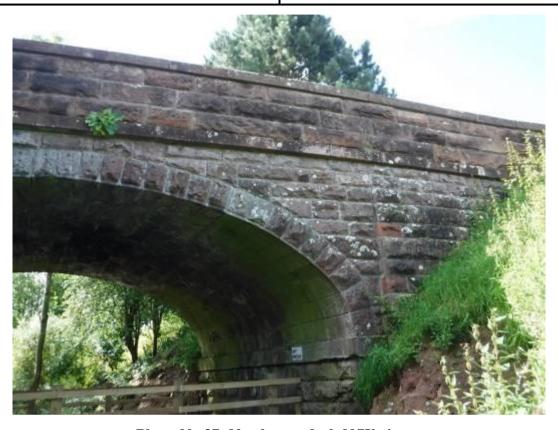
Photo No.37: North spandrel: N/W view.

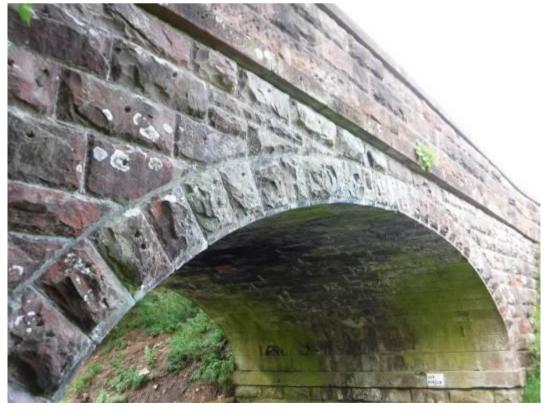
Photo No.38: North spandrel: Separation fracture above the extrados has been pointed.

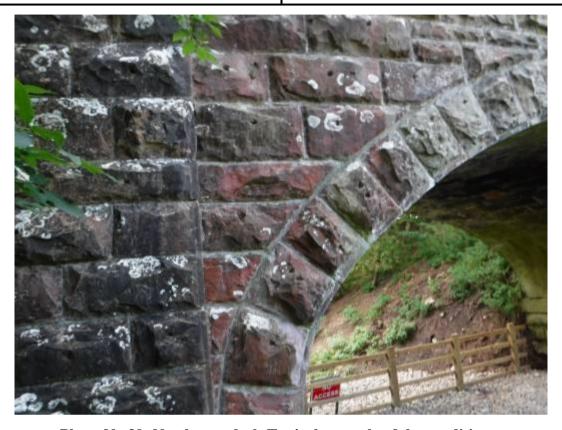
Photo No.39: North spandrel: Typical example of the condition.

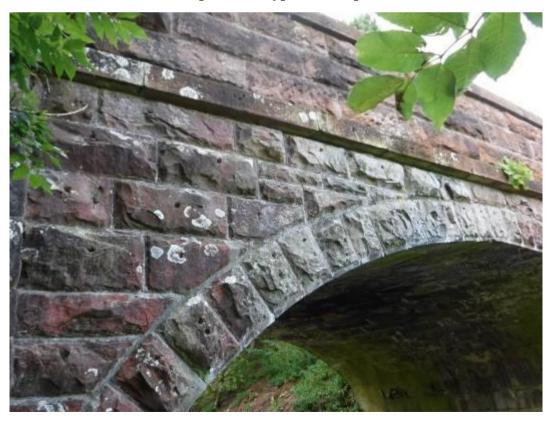
Photo No.40: North spandrel: Typical example of the condition.

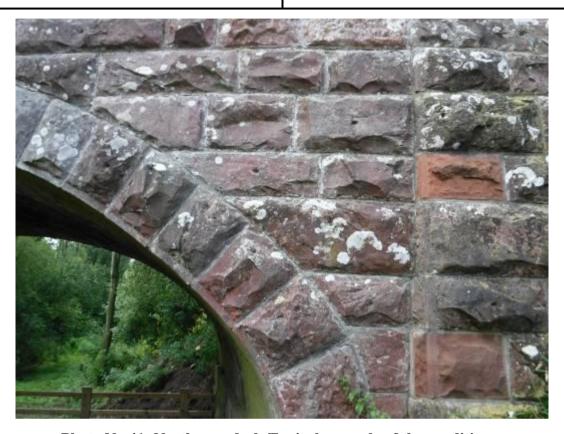
Photo No.41: North spandrel: Typical example of the condition.

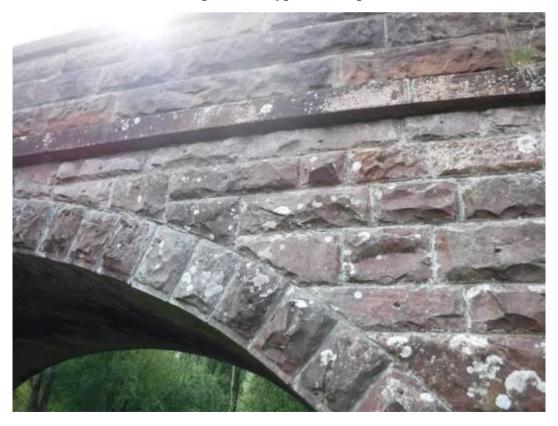
Photo No.42: North spandrel: Typical example of the condition.

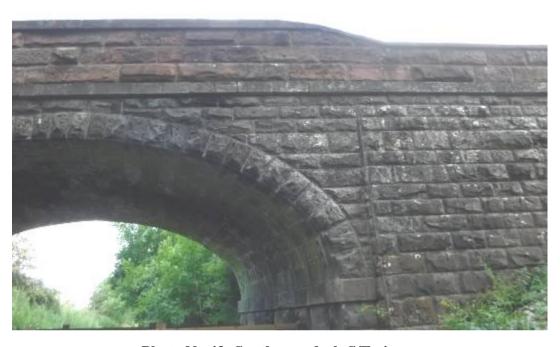
Photo No.43: South spandrel: S/E view.

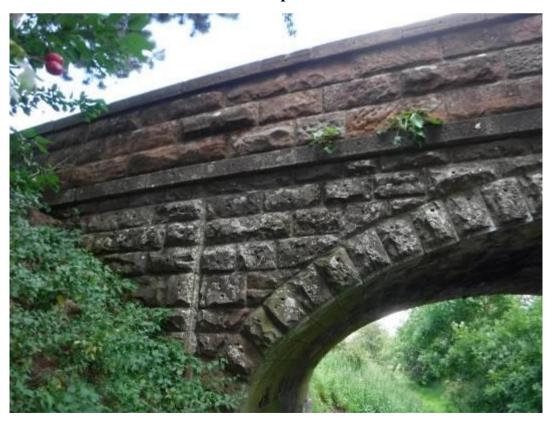
Photo No.44: South spandrel: S/W view.

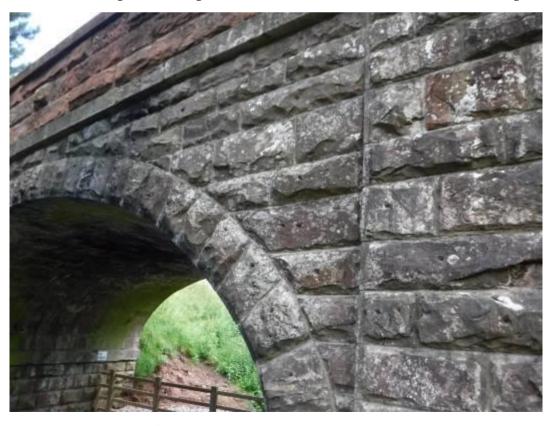
Photo No.46: South spandrel: Typical example of the condition.

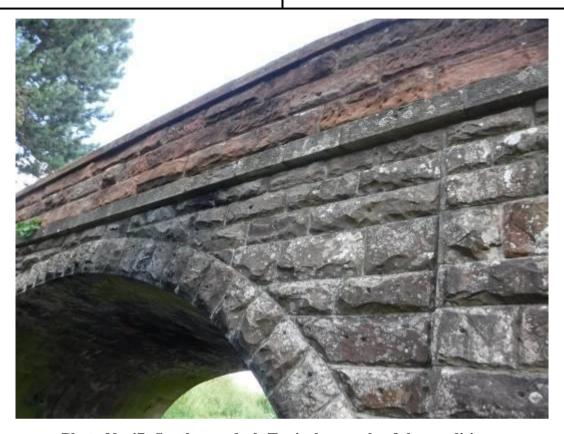
Photo No.47: South spandrel: Typical example of the condition.

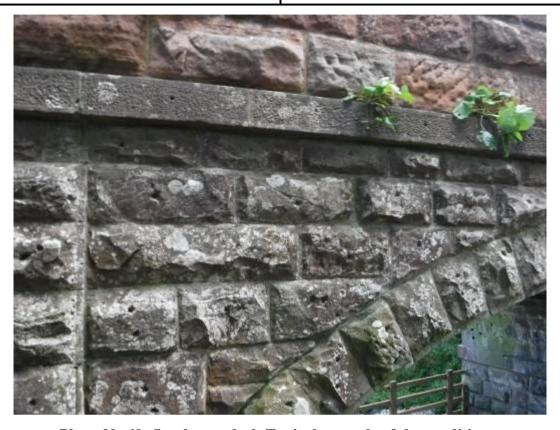
Photo No.49: South spandrel: Typical example of the condition.

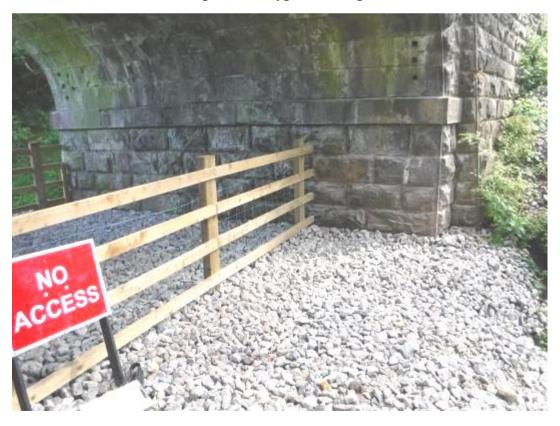
Photo No.50: East abutment: View.

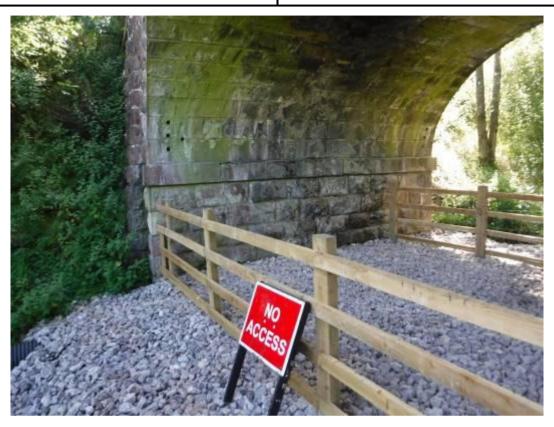
Photo No.51: East abutment: View.

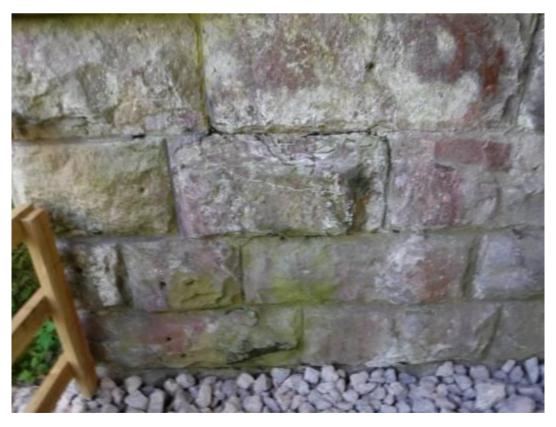
Photo No.52: East abutment: Erosion with loss of face to stonework.

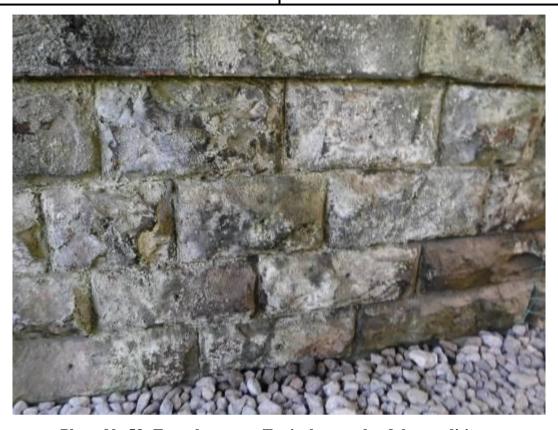
Photo No.53: East abutment: Typical example of the condition.

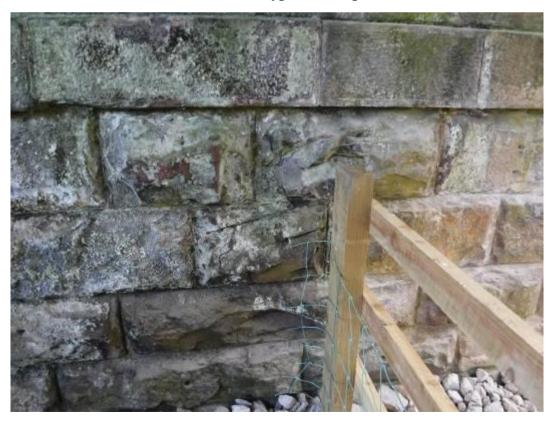
Photo No.54: East abutment: Typical example of the condition.

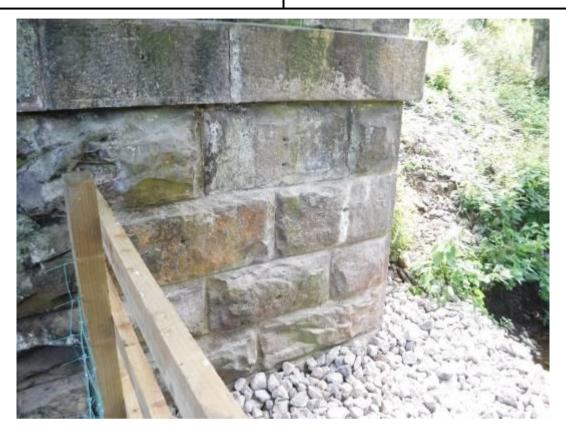
Photo No.55: East abutment: Typical example of the condition.

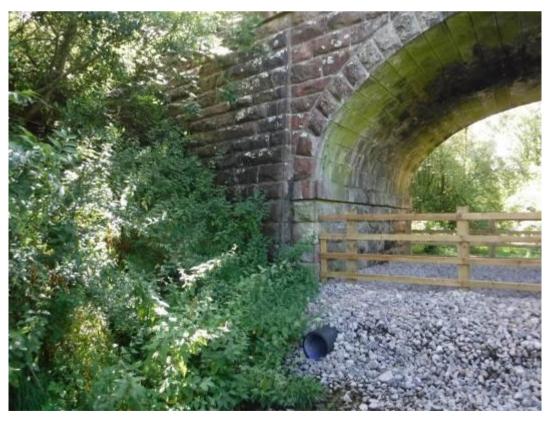
Photo No.56: East abutment: Typical example of the condition to the N/E return section.

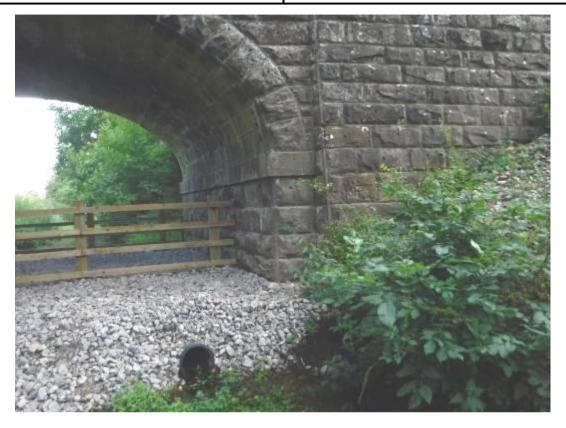
Photo No.57: East abutment: Typical example of the condition to the S/E return section.

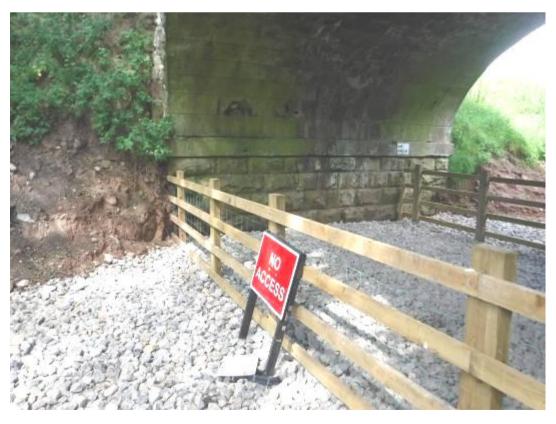
Photo No.58: West abutment: View.

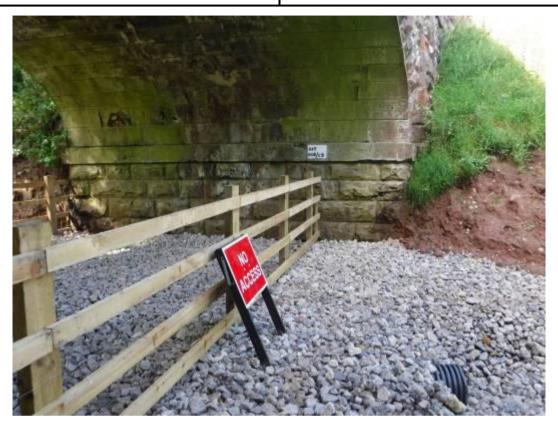
Photo No.59: West abutment: View.

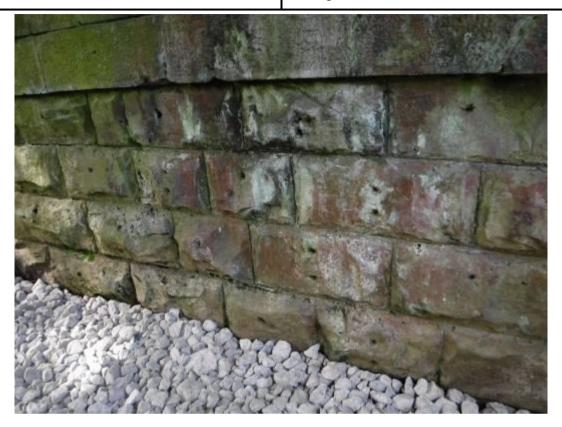
Photo No.61: West abutment: Typical example of the condition.

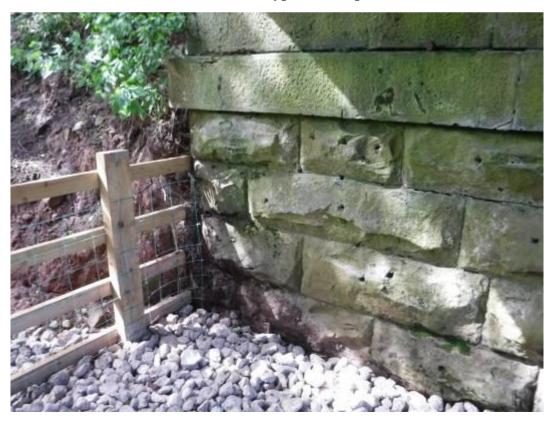
Photo No.62: West abutment: Typical example of the condition.

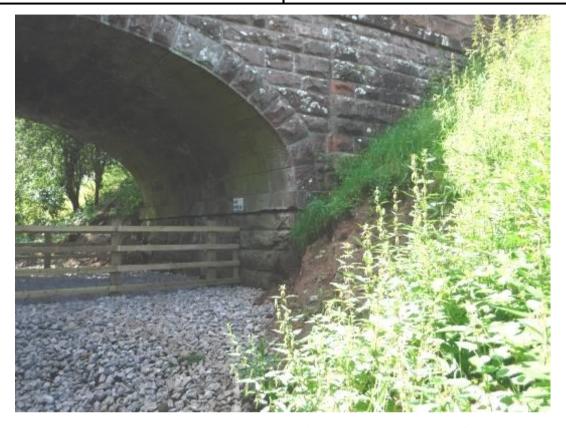
Photo No.63: West abutment: Typical example of the condition at the N/W return section.

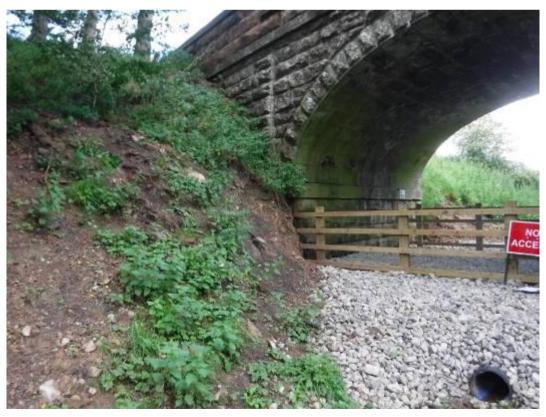
Photo No.64: West abutment: Typical example of the condition at the S/W return section.

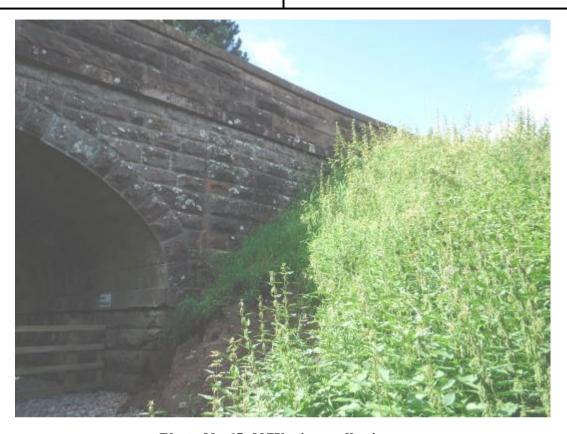
Photo No.65: N/W wing wall: view.

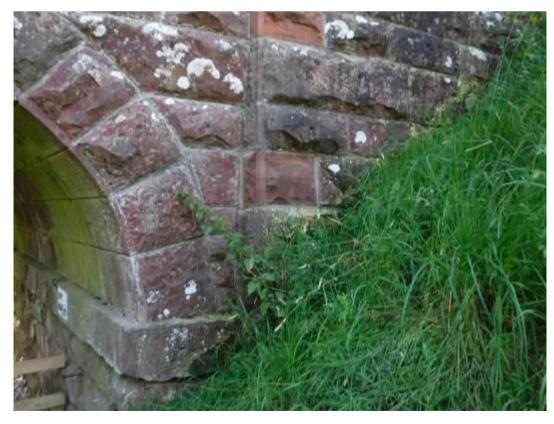
Photo No.66: N/W wing wall: Stonework repairs at return quoin, 400mm from G/L.

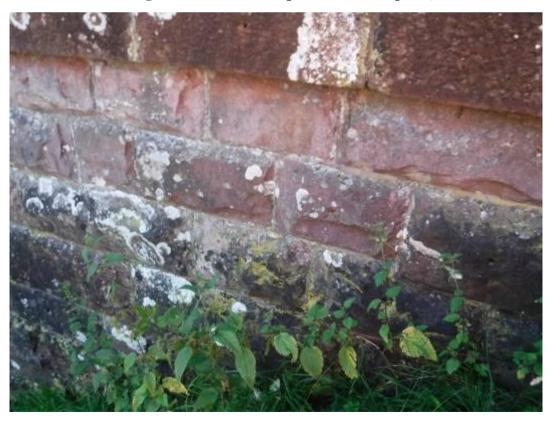
Photo No.68: N/W wing wall: Typical example of the condition.

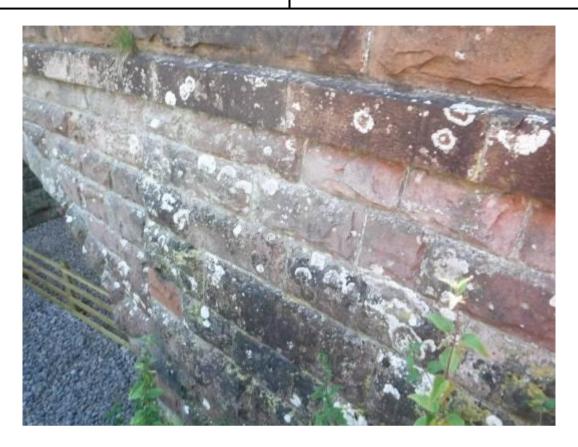
Photo No.69: N/W wing wall: Typical example of the condition.

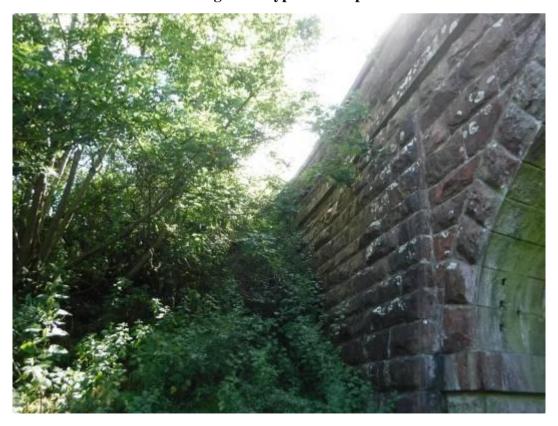
Photo No.70: N/E wing wall: View.

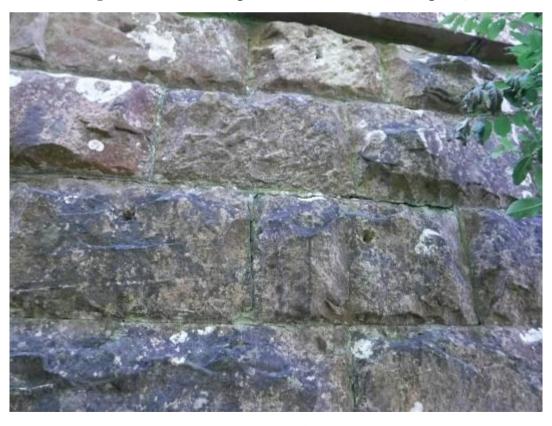
Photo No.72: N/E wing wall: Bulging/oversailing to the stonework.

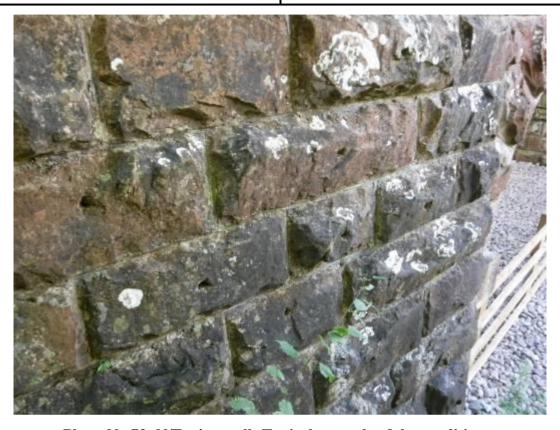
Photo No.73: N/E wing wall: Typical example of the condition.

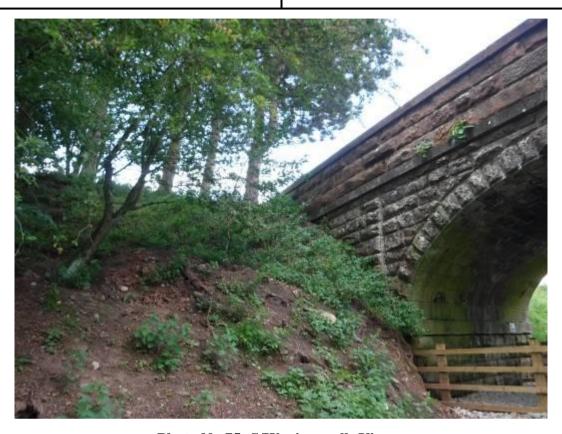
Photo No.75: S/W wing wall: View.

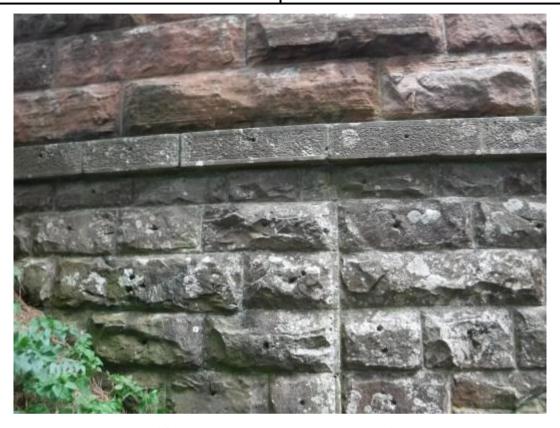
Photo No.77: S/W wing wall: Typical example of the condition.

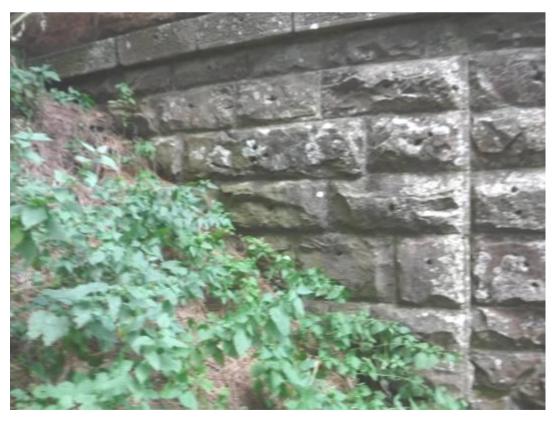
Photo No.78: S/W wing wall: Typical example of the condition.

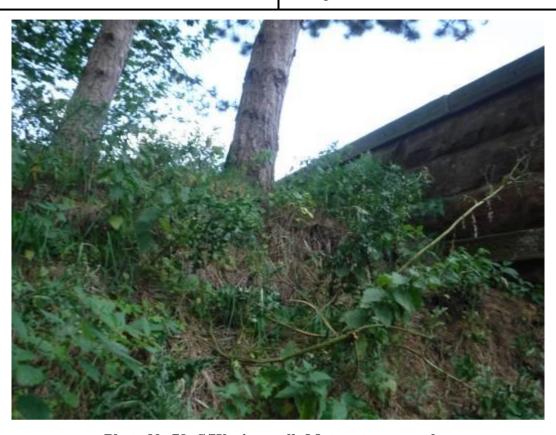
Photo No.79: S/W wing wall: Mature tree growth.

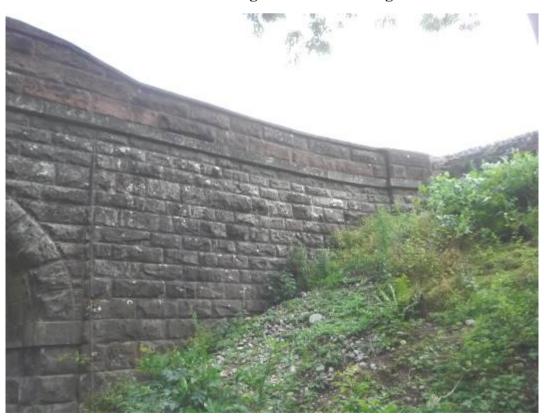
Photo No.80: S/E wing wall: View.

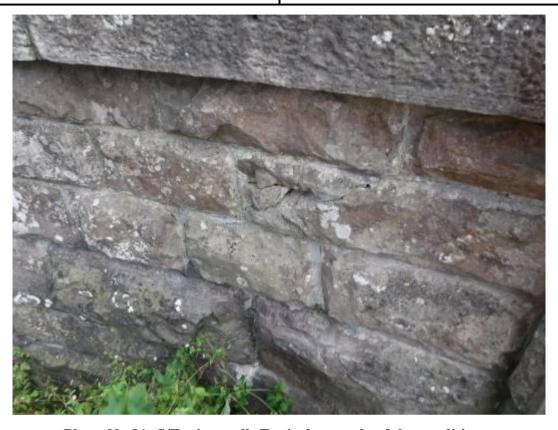
Photo No.81: S/E wing wall: Typical example of the condition.

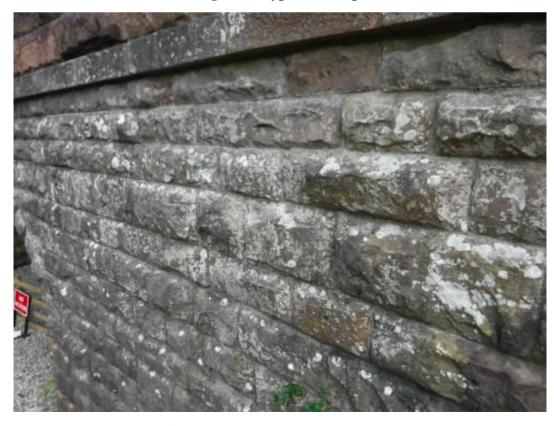
Photo No.82: S/E wing wall: Typical example of the condition.

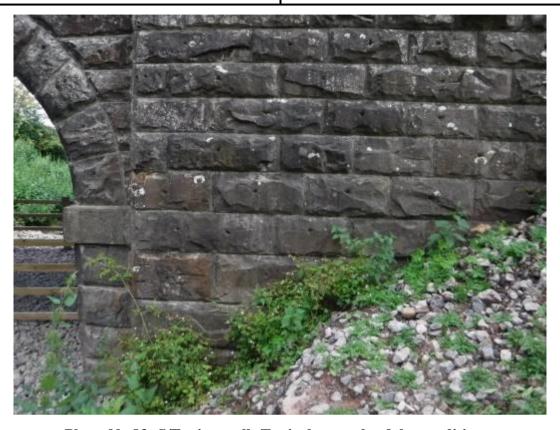
Photo No.83: S/E wing wall: Typical example of the condition.

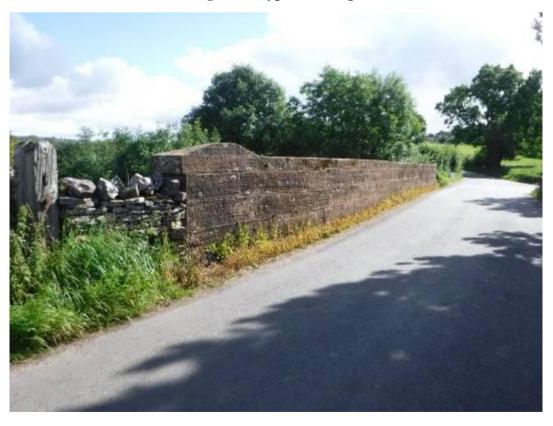
Photo No.84: North roadside parapet: View.

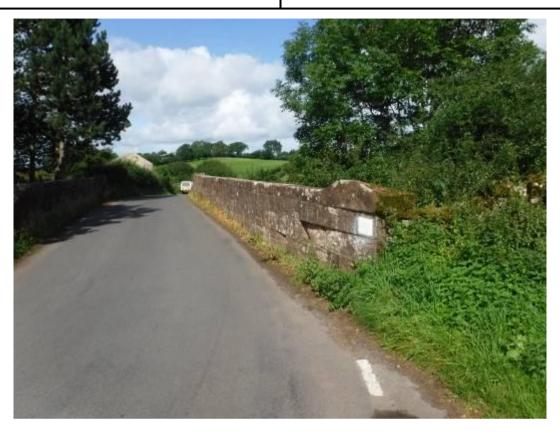
Photo No.85: North roadside parapet: View.

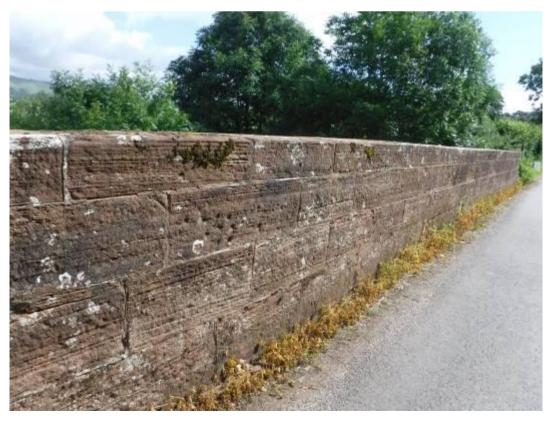
Photo No.86: North roadside parapet: Vehicle impact scrape marks.

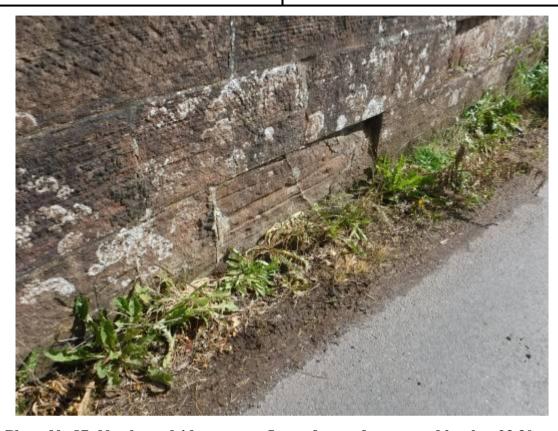
Photo No.87: North roadside parapet: Loss of stone face at road level at 23.30m.

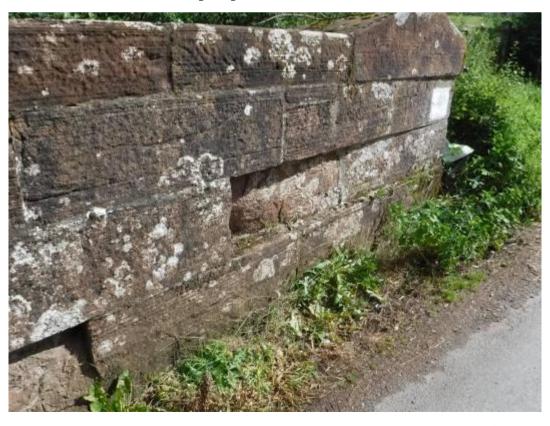
Photo No.88: North roadside parapet: Vehicle impact damage at the N/E end.

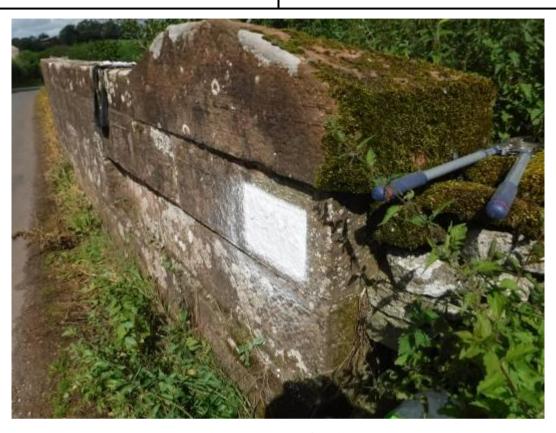
Photo No.89: North roadside parapet: N/E pilaster capstone displaced.

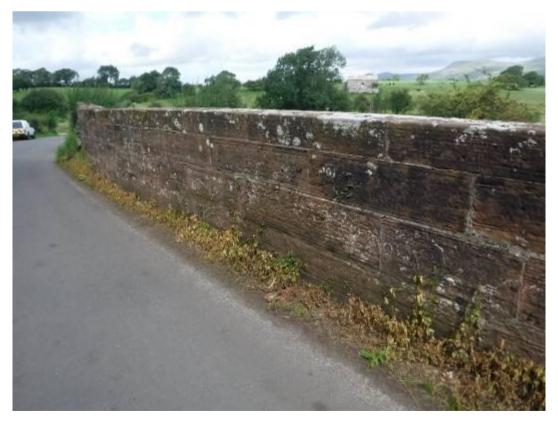
Photo No.90: North roadside parapet: Typical example of the condition.

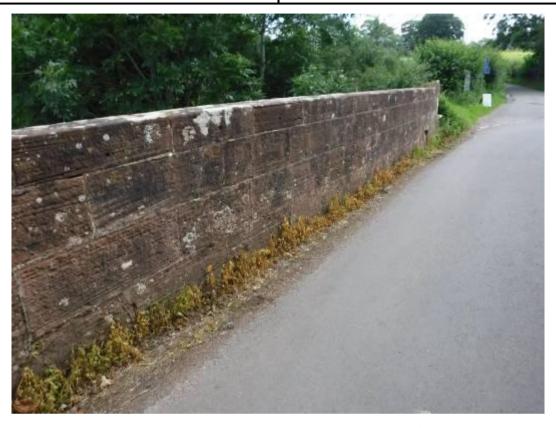
Photo No.91: North roadside parapet: Typical example of the condition.

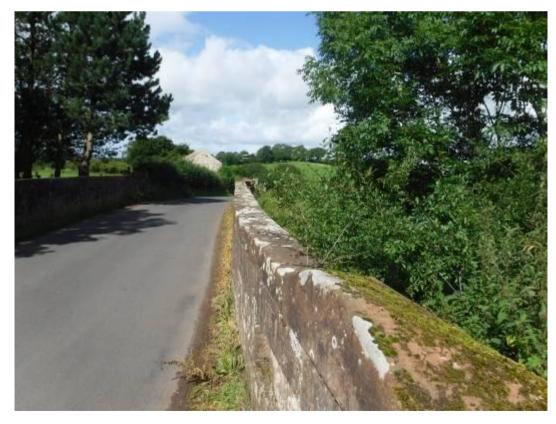
Photo No.92: North roadside parapet: Typical example of the condition of the coping stones.

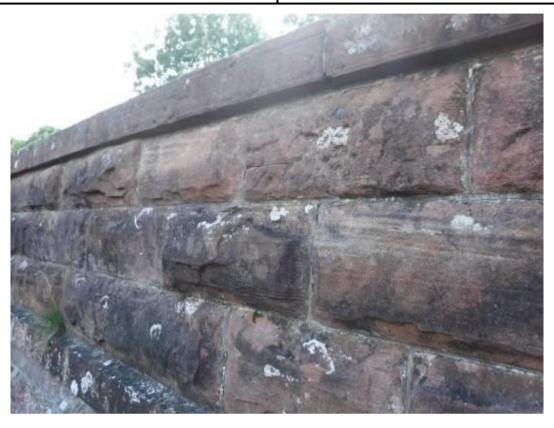
Photo No.95: North outer parapet: Typical example of the condition.

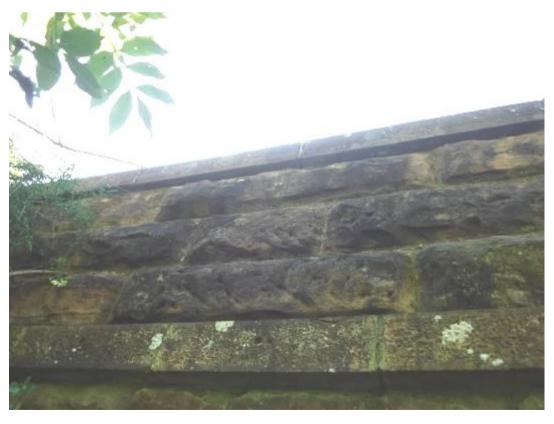
Photo No.96: North outer parapet: Typical example of the condition.

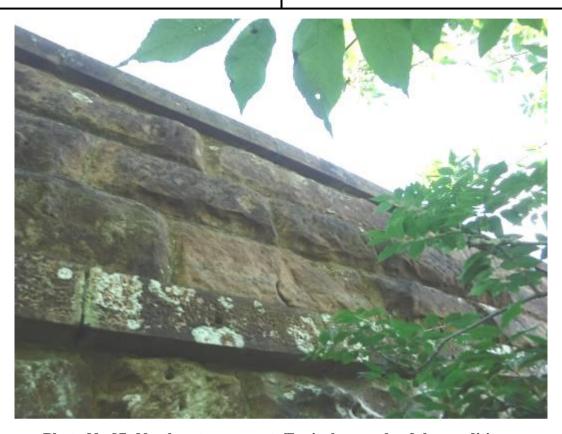
Photo No.97: North outer parapet: Typical example of the condition.

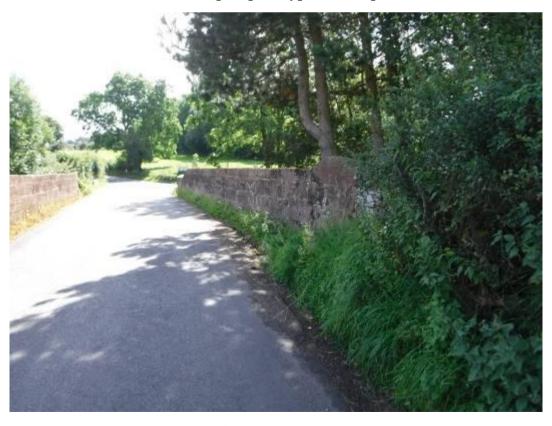
Photo No.98: South roadside parapet: View.

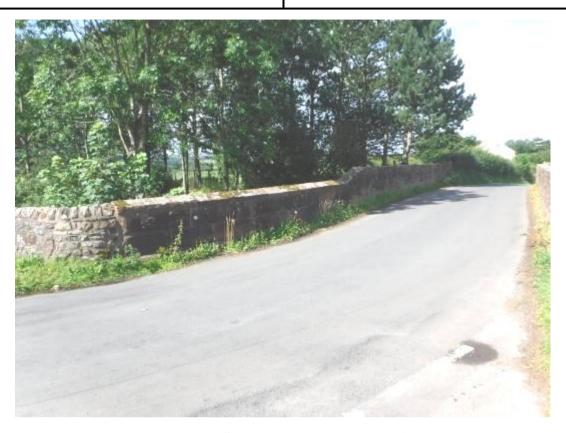
Photo No.99: South roadside parapet: View.

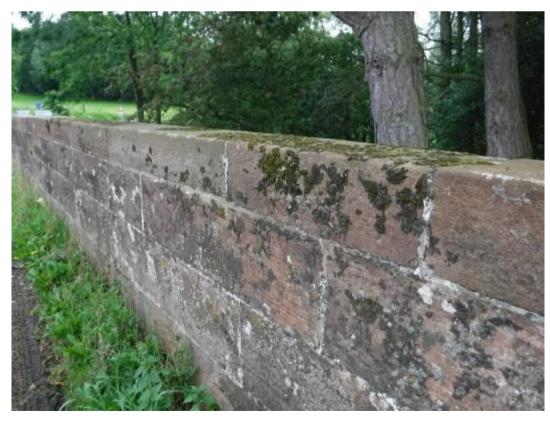
Photo No.100: South roadside parapet: Oversailing to the coping stones at 2.85m to 5.24m.

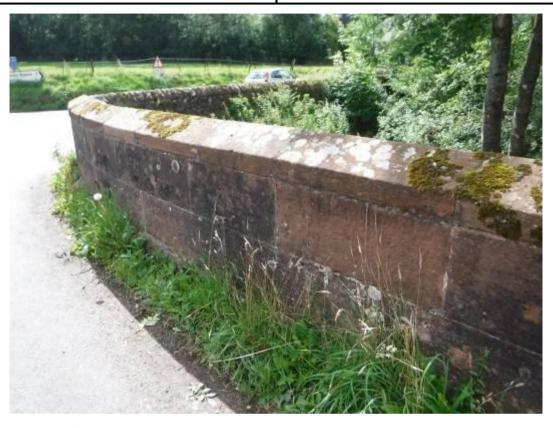
Photo No.101: South roadside parapet: Vehicle impact scrape marks to the coping stones.

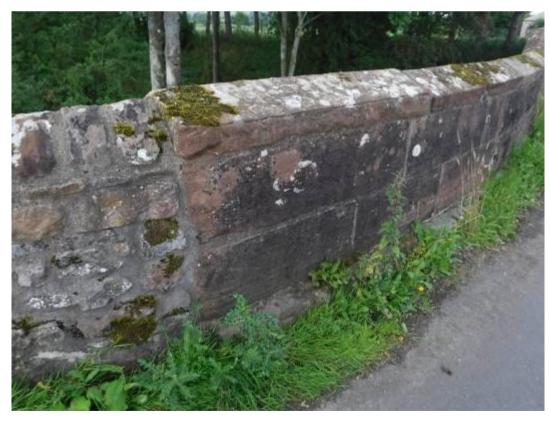
Photo No.102: South roadside parapet: Possible vehicle impact damage to the S/E end.

New impact damage is noted at the east quoin of the south parapet since the previous detailed and

South:- internal road face: impact damage was noted from the east quoin over a max length of 2.4m inclusive of the copings. Inward displacement was noted along the 2nd quoin stone from G/L over a length of 1.36m up to 12mm with the copings found displaced up to a max of 22mm. Due to the density of the stone and copings the affected area remains secure under hammer (**photos 16 to 18**). Some loose fragments of sheared stone/spalling within the affected stone and copings were removed at the time of the examination (**photos 19 & 20**). Local knowledge advised the examiner that the parapet was struck in Spring 2019 by a local farmer. Lifting/pushing mortar is noted to external face of the parapet opposite the impact damage (**photo 21**). "Possible" impact damage at this area was noted at time of the previous detailed examination report (photo 102 within the DE).

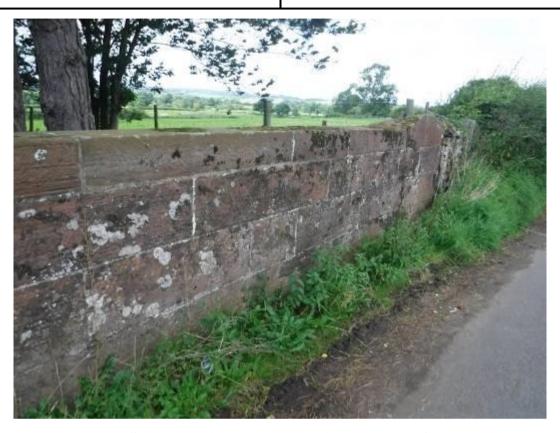
Photo No.103: South roadside parapet: Typical example of the condition.

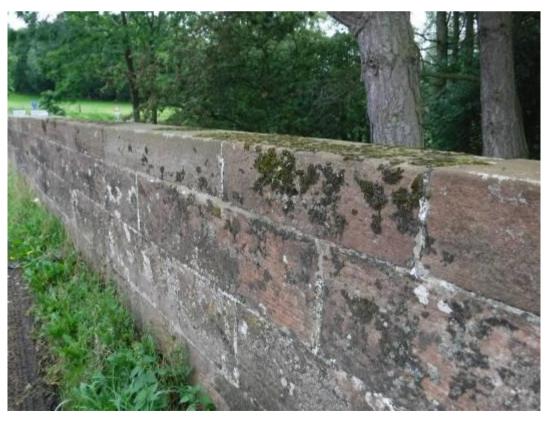
Photo No.104: South roadside parapet: Typical example of the condition.

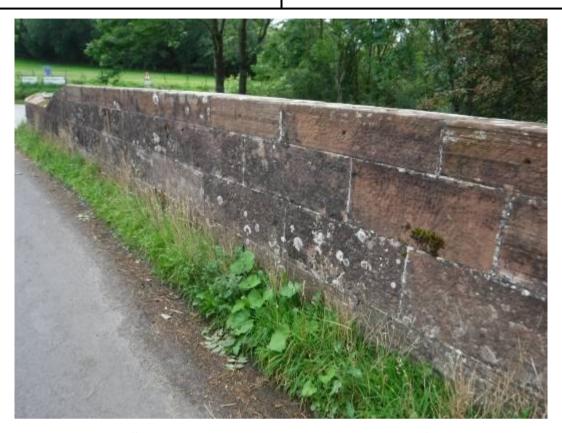
Photo No.105: South roadside parapet: Typical example of the condition.

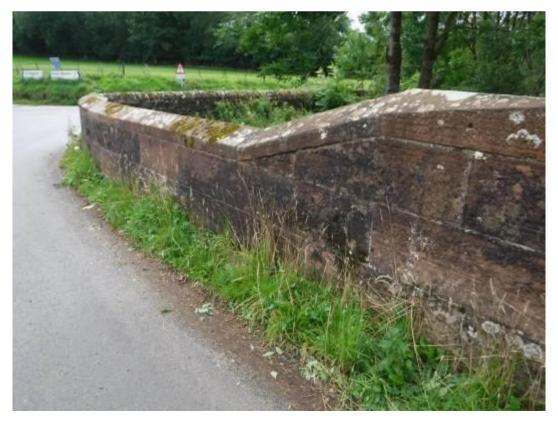
Photo No.106: South roadside parapet: Typical example of the condition.

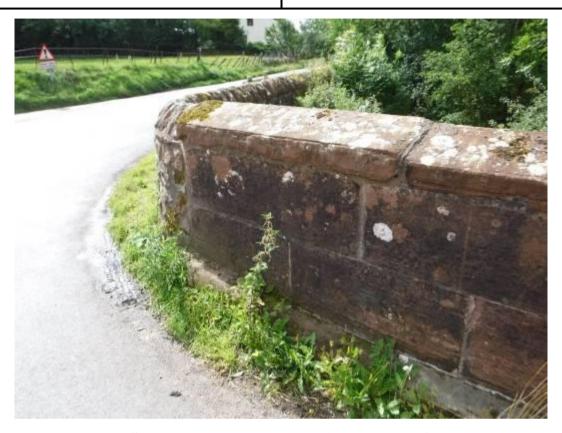
Photo No.107: South roadside parapet: Typical example of the condition.

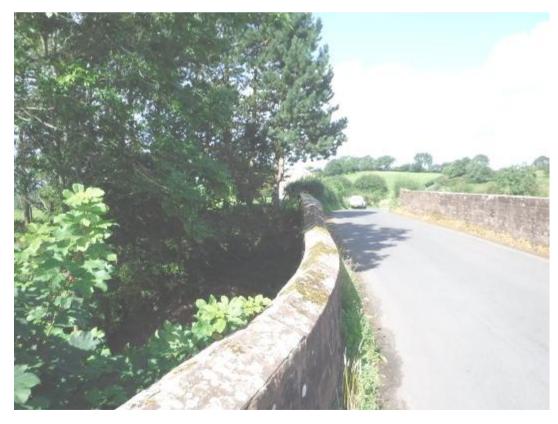
Photo No.108: South roadside parapet: Typical example of the condition of the coping stones.

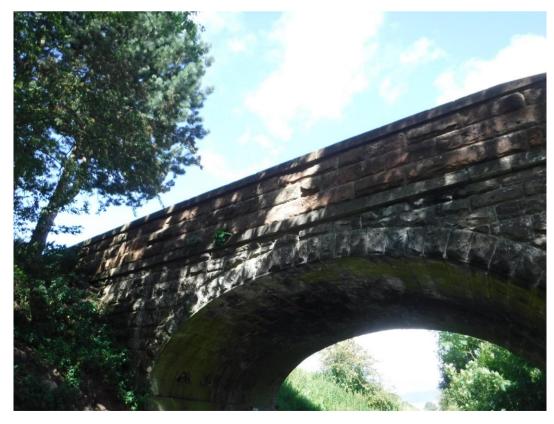
Photo No.110: South outer parapet: Typical example of the condition.

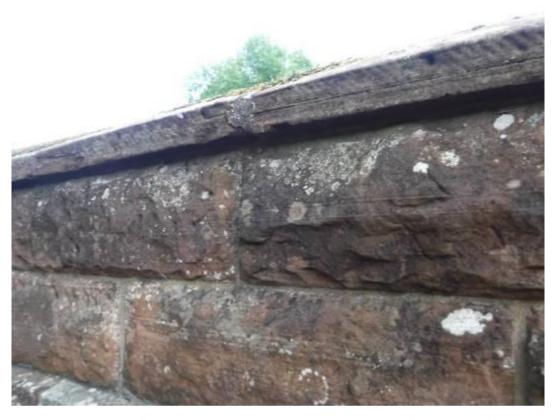
Photo No.111: South outer parapet: Typical example of the condition.
