BRIDGE ASSESSMENT TO BD21/97

B6259 - GREAT MUSGRAVE RAILWAY BRIDGE NO 25

BD 21/97 LOAD ASSESSMENT REPORT

ELR:	EDE	Structure No:	25	Mileage:	Examination date:	08/02/20
Route:	Eden	Valley Jn - Kirkby	Stephen ((Warcop Branch)	OS ref: NY 765 130	6
Name:	Great	Musgrave			Type: Over bridge

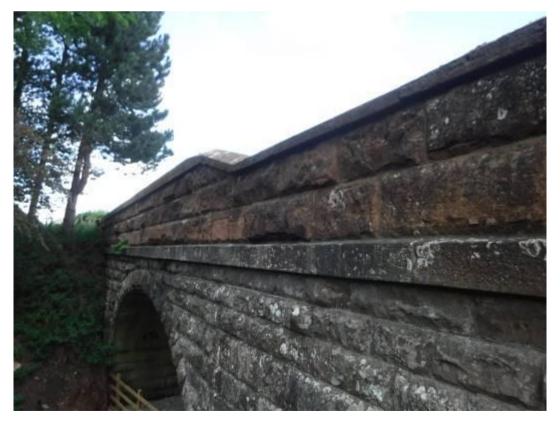
Photo No.112: South outer parapet: Typical example of the condition.

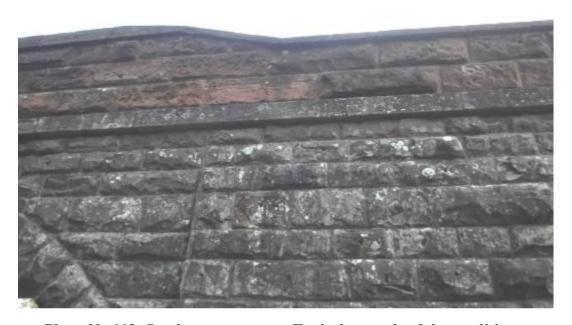
Photo No.113: South outer parapet: Typical example of the condition.

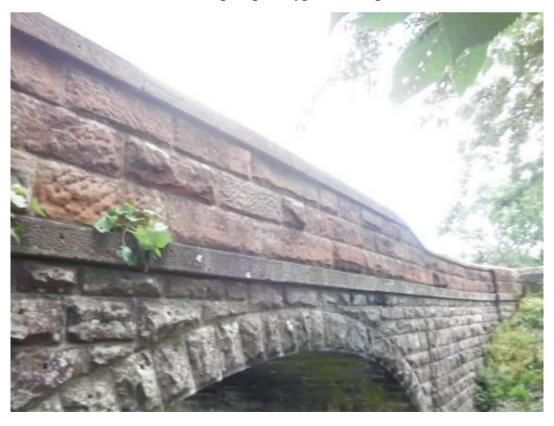
Photo No.114: South outer parapet: Typical example of the condition.

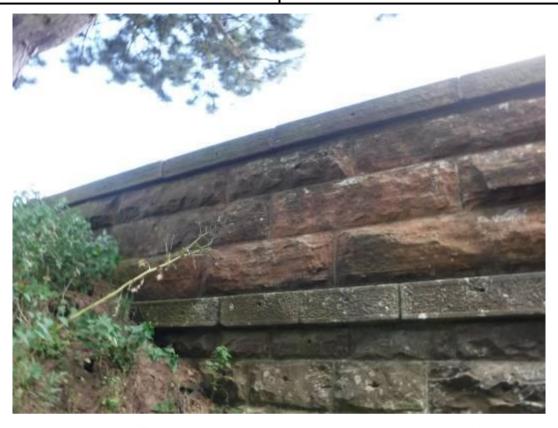
Photo No.115: South outer parapet: Typical example of the condition.

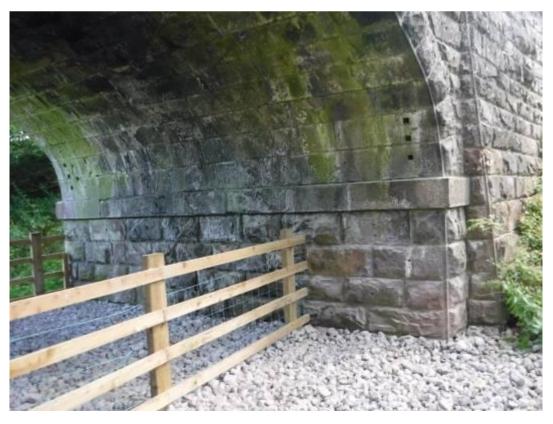
Photo No.116: East springer course: View.

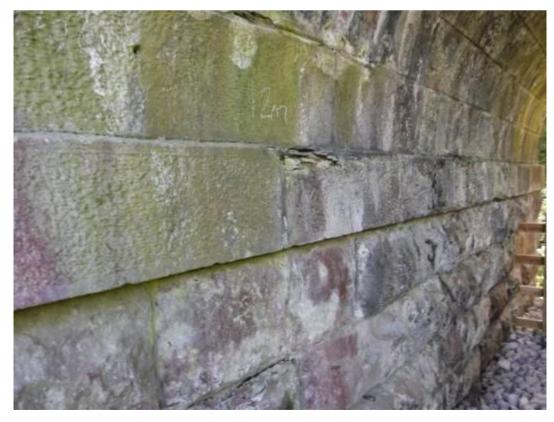
Photo No.118: East springer course: Erosion with loss of face to the stonework, 1.20m from the N/E quoin.

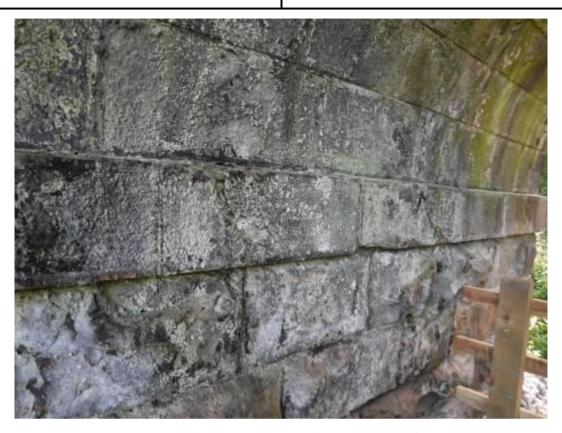
Photo No.119: East springer course: Typical example of the condition.

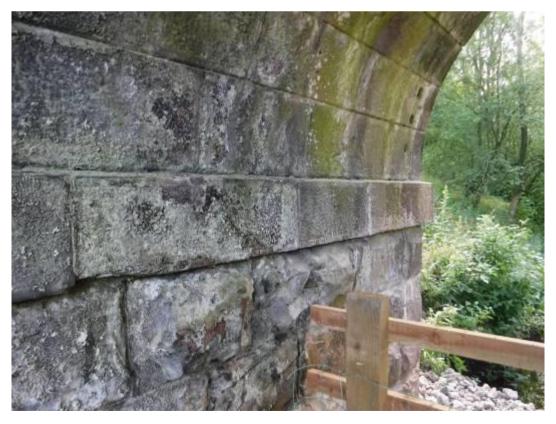
Photo No.120: East springer course: Typical example of the condition.

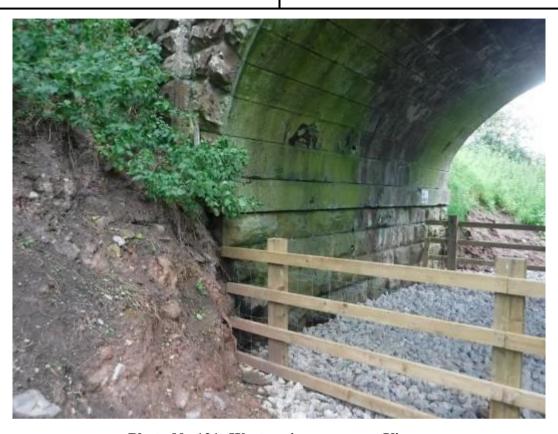
Photo No.121: West springer course: View.

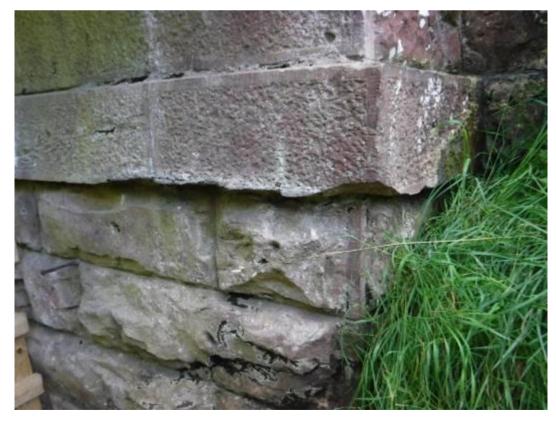
Photo No.122: West springer course: Moderate erosion with loss of face to the stonework at the N/W quoin.

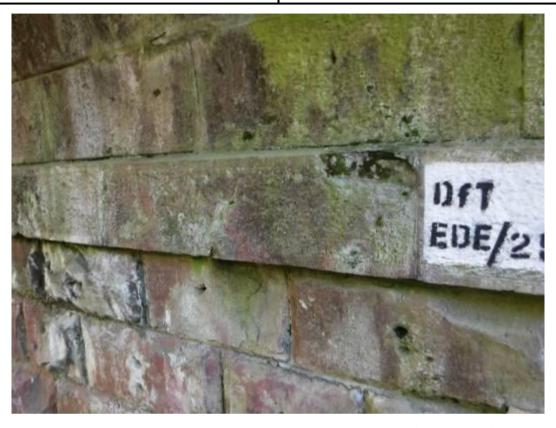
Photo No.123: West springer course: Typical example of the condition.

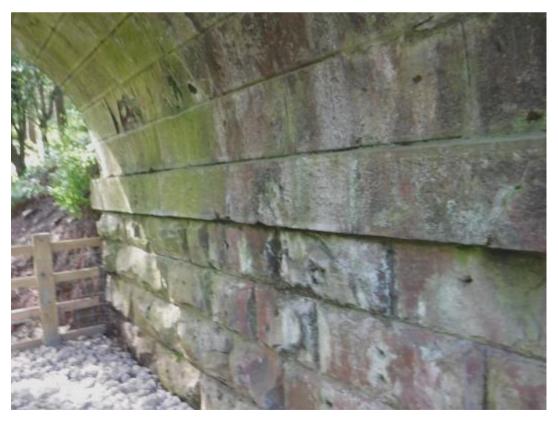
Photo No.124: West springer course: Typical example of the condition.

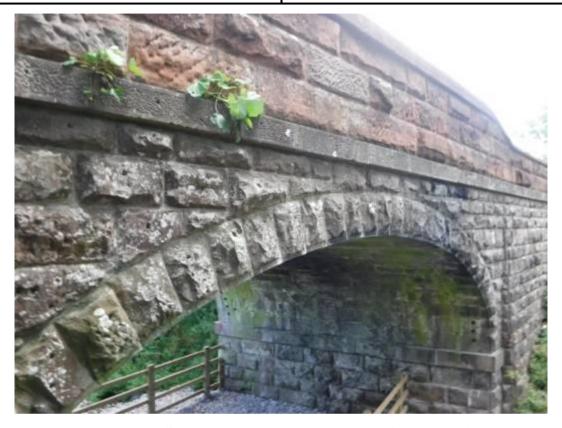
Photo No.125: String course: Typical example of the condition.

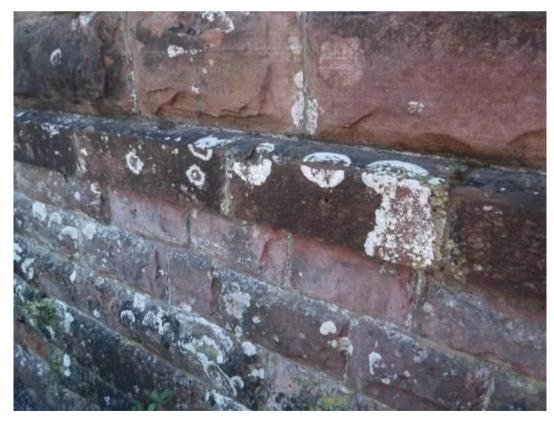
Photo No.126: String course: Typical example of the condition.

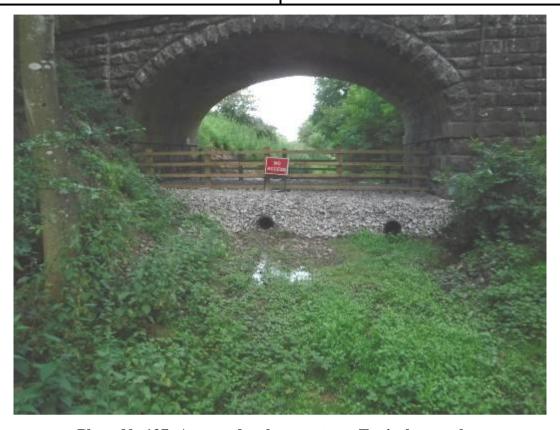
Photo No.127: Area under the structure: Typical example.

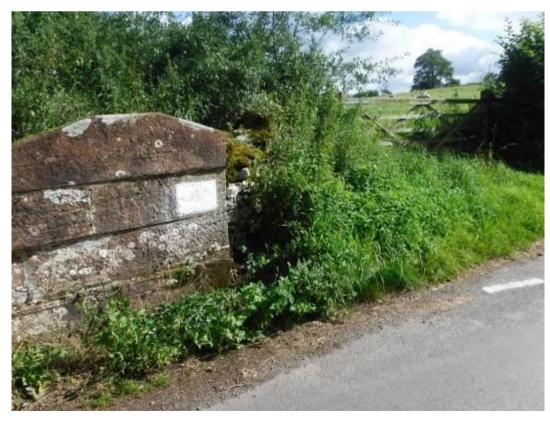
Photo No.128: Approach road walling: Typical example of the condition at N/E end.

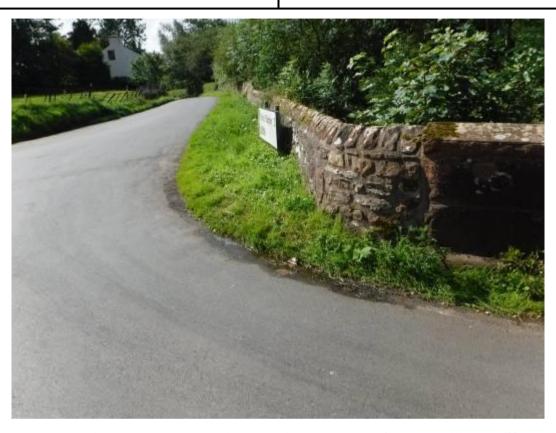
Photo No.129: Approach road walling: Typical example of the condition at S/E end.

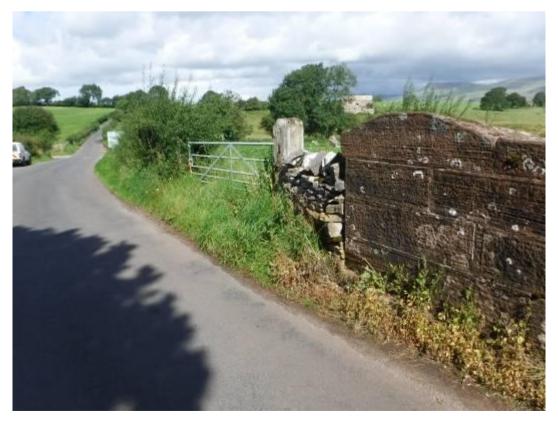
Photo No.130: Approach road walling: Typical example of the condition at N/W end.

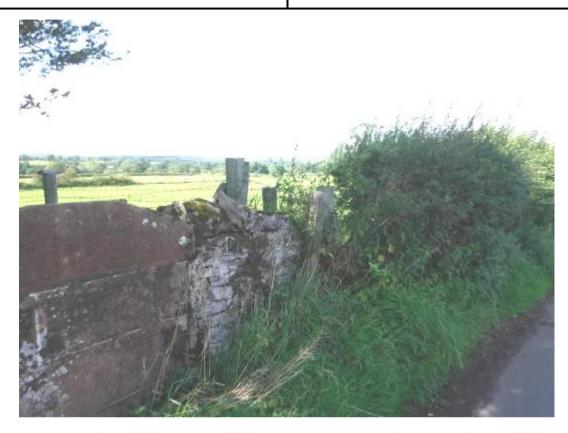
Photo No.131: Approach road walling: Typical example of the condition at S/W end.

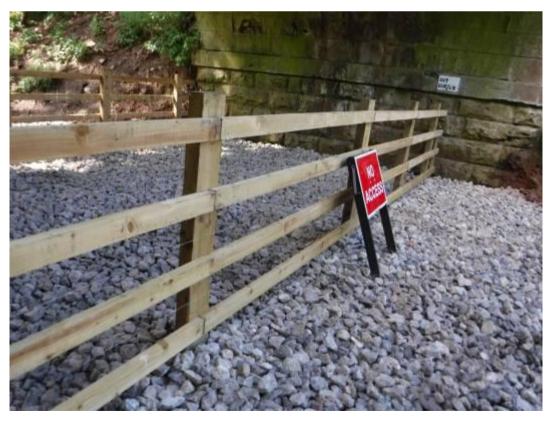
Photo No.132: Fencing under the structure: Typical example.

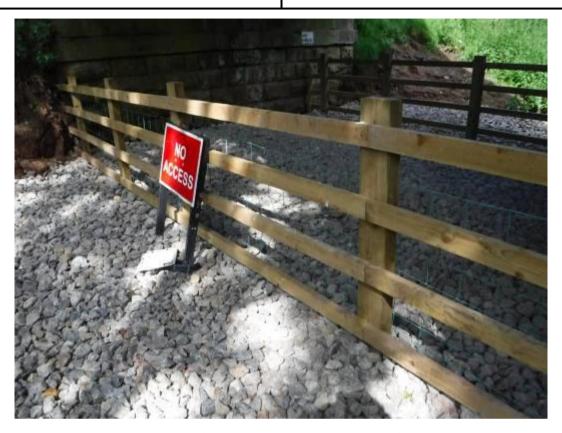
Photo No.133: Fencing under the structure: Typical example.

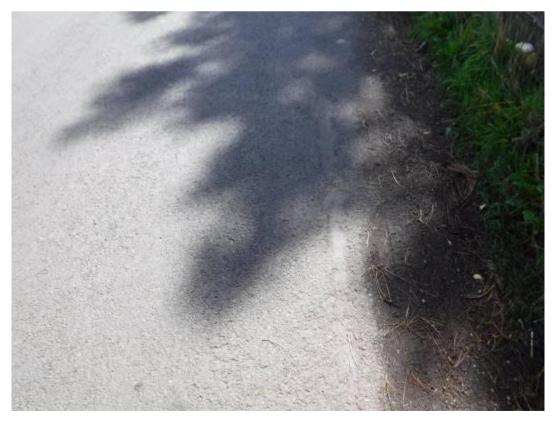
Photo No.134: Road surface: Typical example of the condition.

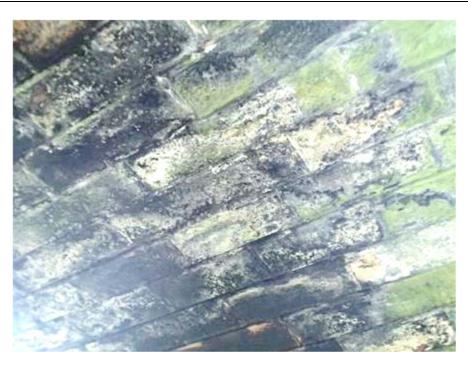
Long-standing downward alignment defects were noted along the transverse joint lines of individual stones within the soffit at crown and the east upper haunch. The downward alignment along the stonework was noted up to approx 15mm where accessible. Alignment defects within the soffit were noted up to 4mm at time of the detailed examination (photos 11 to 13).

Photograph 11: example of long-standing downward alignment defects noted within the soffit

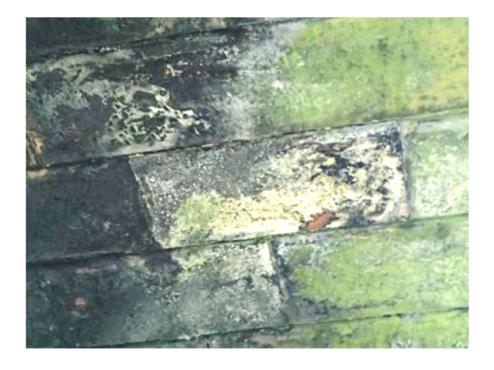
Photograph 12: example of long-standing downward alignment defects noted within the soffit The downward alignment defects were noted up to approx 15mm

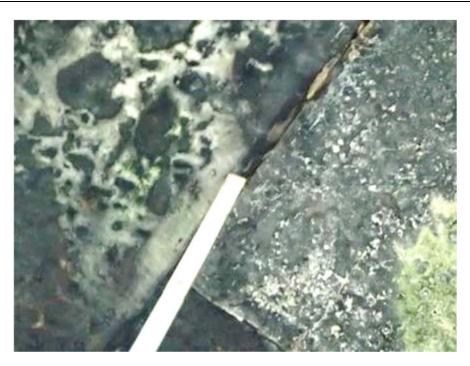
Photograph 13: The downward alignment defects were noted up to approx 15mm Denoted to 4mm at time of the detailed examination

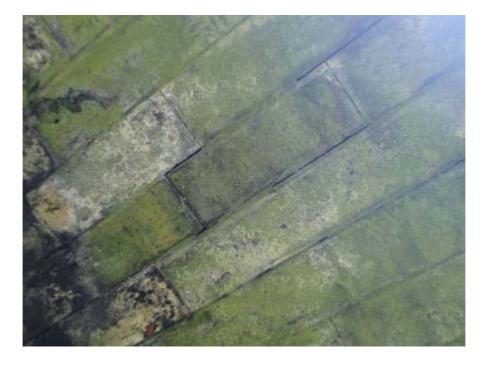
A number of joints within the soffit showed mortar loss up to 170mm where accessible. The mortar loss was noted up to a max of 40mm at time of the previous detailed examination (photos 14 & 15).

Photograph 14: example of open joints located within the soffit

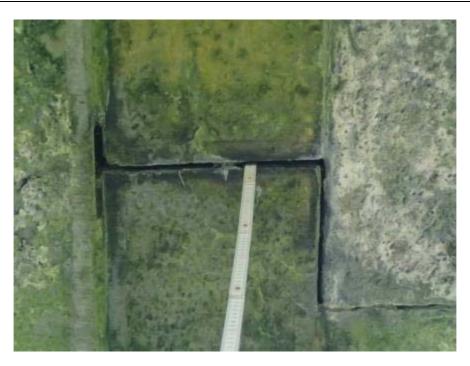
Photograph 15: the mortar loss was noted up to 170mm where accessible

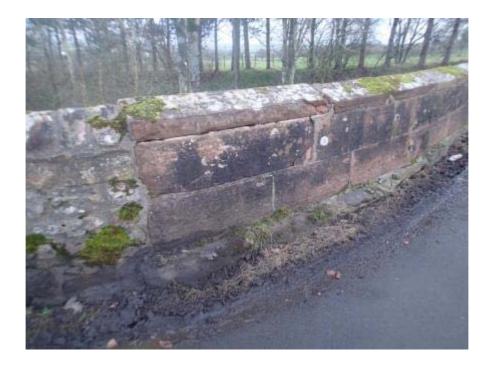
South:- internal road face: impact damage was noted from the east quoin over a max length of 2.4m inclusive of the copings. Inward displacement was noted along the 2nd quoin stone from G/L over a length of 1.36m up to 12mm with the copings found displaced up to a max of 22mm. Due to the density of the stone and copings the affected area remains secure under hammer (**photos 16 to 18**). Some loose fragments of sheared stone/spalling within the affected stone and copings were removed at the time of the examination (**photos 19 & 20**). Local knowledge advised the examiner that the parapet was struck in Spring 2019 by a local farmer. Lifting/pushing mortar is noted to external face of the parapet opposite the impact damage (**photo 21**). "Possible" impact damage at this area was noted at time of the previous detailed examination report (photo 102 within the DE).

Photograph 16: impact damage noted at the east quoin of the south parapet

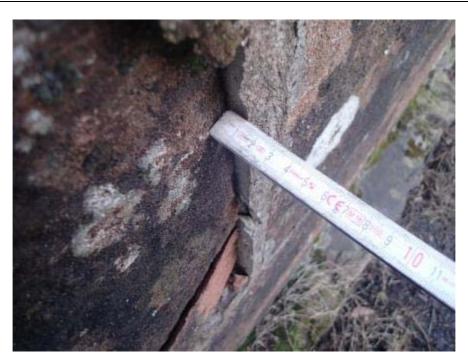
Photograph 17: displacement of the quoin stone was noted up to 12mm

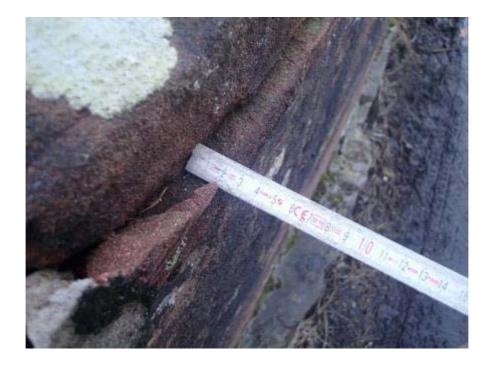
Photograph 18: displacement of the copings was noted up to 22mm

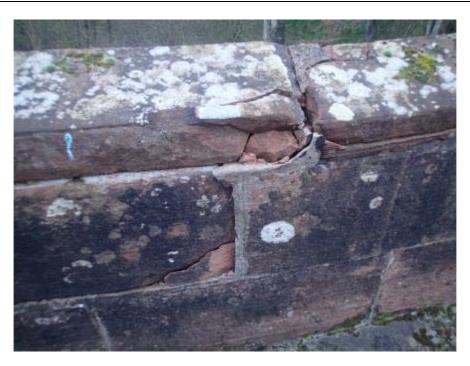
Photograph 19: spalled/sheared stone noted due to impact damage

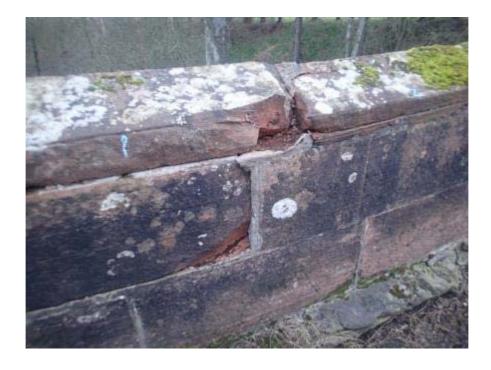
Photograph 20: the spalled/sheared stone fragments were removed at time of the examination

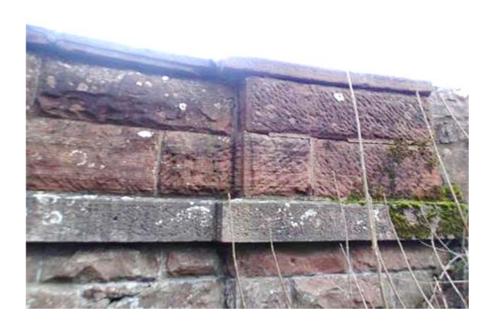
Photograph 21: general condition of the external face of the south parapet opposite the impact damage noted within the internal face

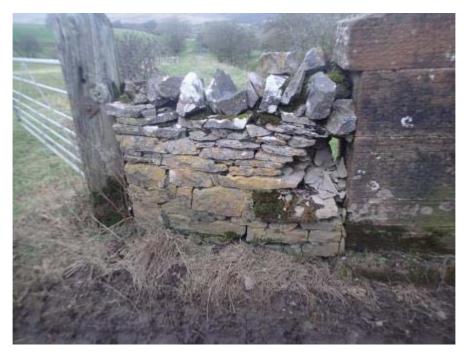
Northwest:- small section of stone walling extends off the end of the parapet. Stone loss is noted adjacent to the parapet over a height of 450mm x a width of 390mm (photos 22 & 23).

Photograph 22: stone loss noted to stone wall extending off the west quoin of the north parapet

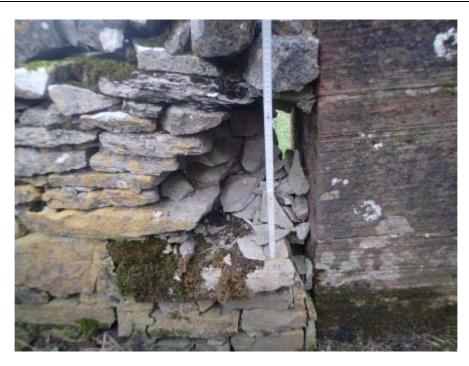
Photograph 23: stone loss within the wall extending off the west quoin of the north parapet

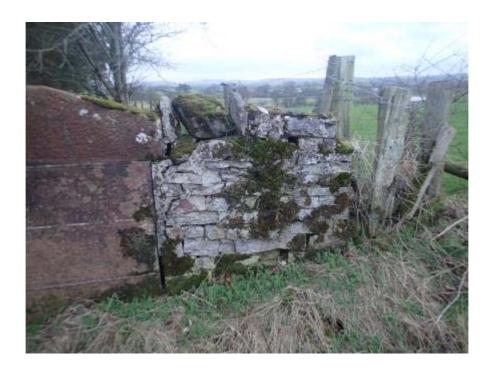
Southwest:- small section of stone walling extends off the end of the parapet. The stonework is loose to hammer (photo 24).

Photograph 24: loose stonework noted within the wall extending off the west quoin of the south parapet

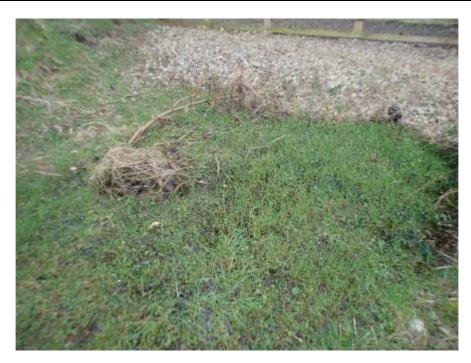
The redundant track bed is found waterlogged to both the north and south of the structure (photo 25).

Photograph 25: example of waterlogged ground located to both the north and south ends of the structure

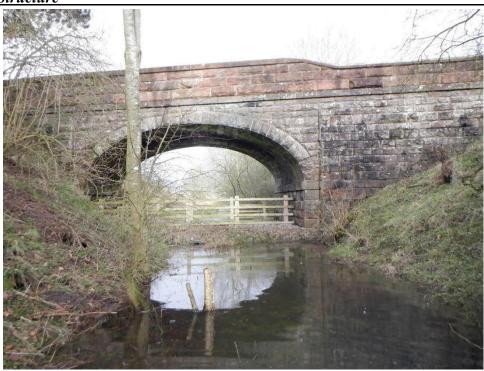
Photograph 1: South elevation.

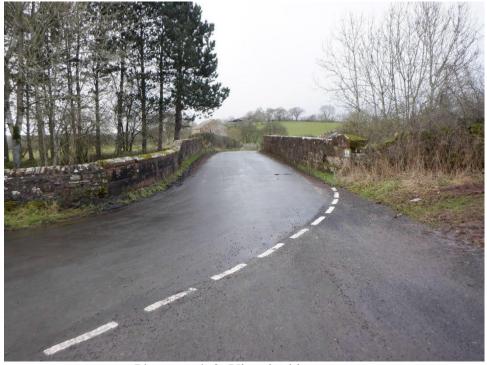
Photograph 2: View looking west.

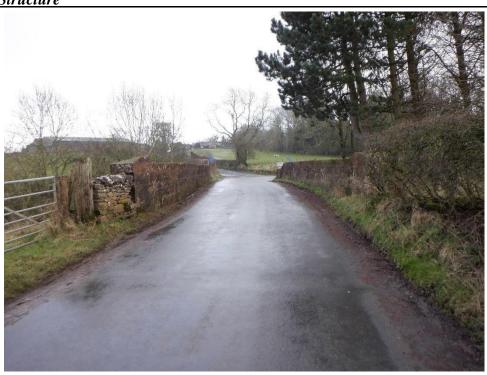
Photograph 3: View looking east.

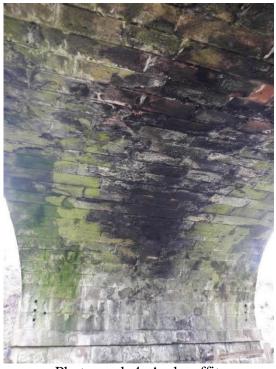
Photograph 4: Arch soffit.

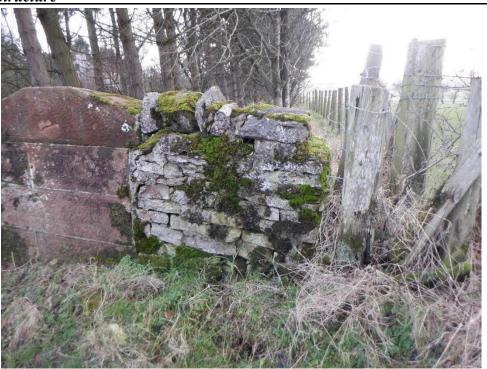
Photograph 5: SW Approach Wall, serviceable.

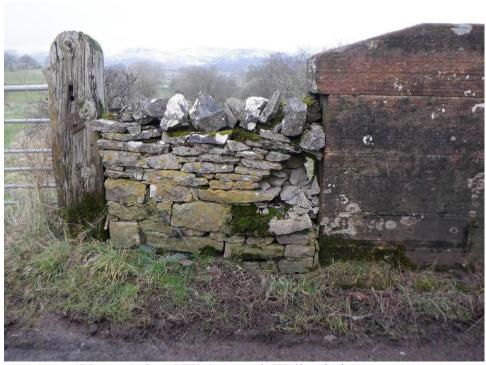
Photograph 6: NW Approach Wall, missing stones.

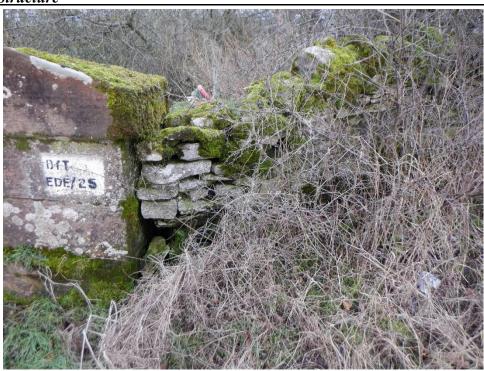
Photograph 7: NE Approach Wall, drystone wall, falling into disrepair.

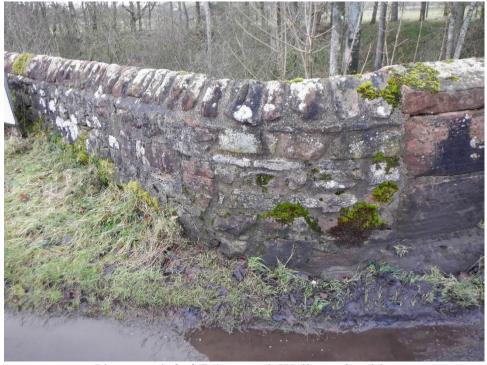
Photograph 8: SE Approach Wall, serviceable.

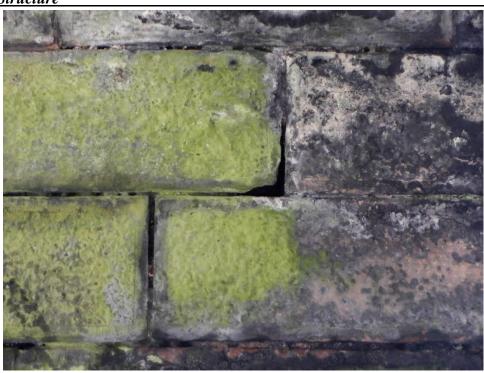
Photograph 9: Arch soffit, displaced blocks & DOJ's.

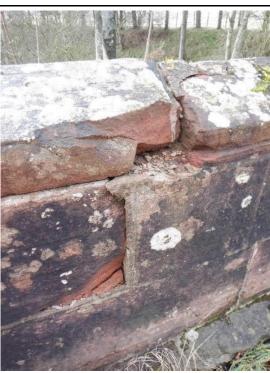
Photograph 11: SE wingwall parapet (roadside view), 2019/20 bridge bash damage.

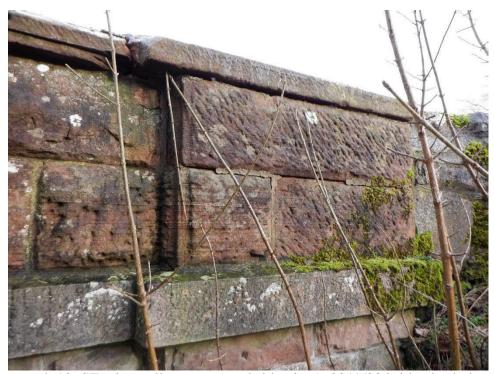
Photograph 12: SE wingwall parapet (trackside view), 2019/20 bridge bash damage.
